Shelly to Moffat Beach Coastal Study

Final Report and Action Plan

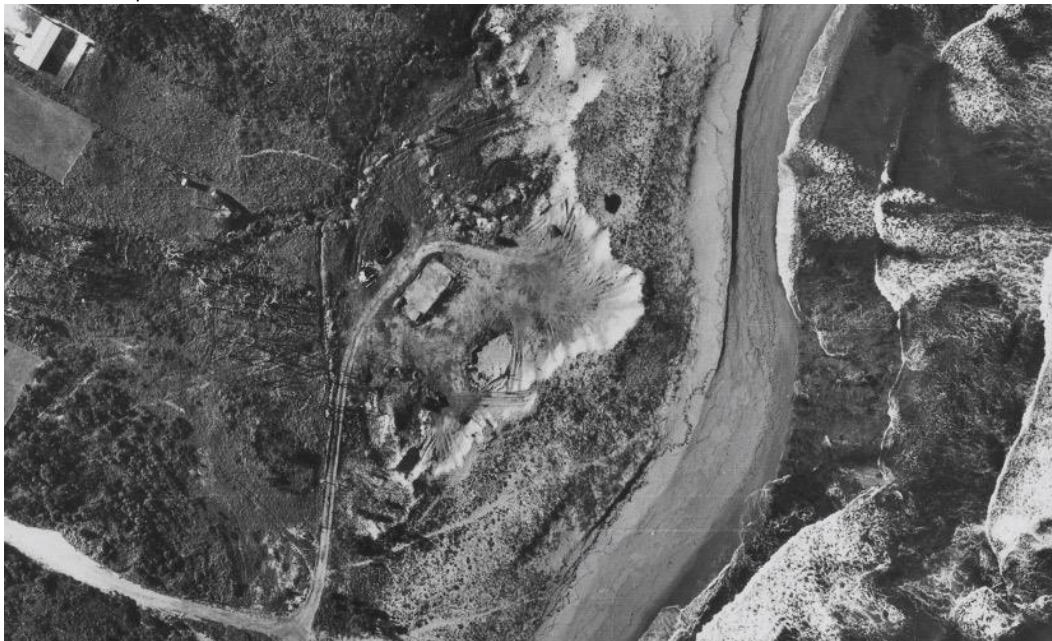
Figure 5: 30 October 1962

Sand/ Shell grit quarrying operation in progress on the foredune and vegetation cover increased, probably due to favourable seasonal conditions, and at the same time a new dune has built up seaward.

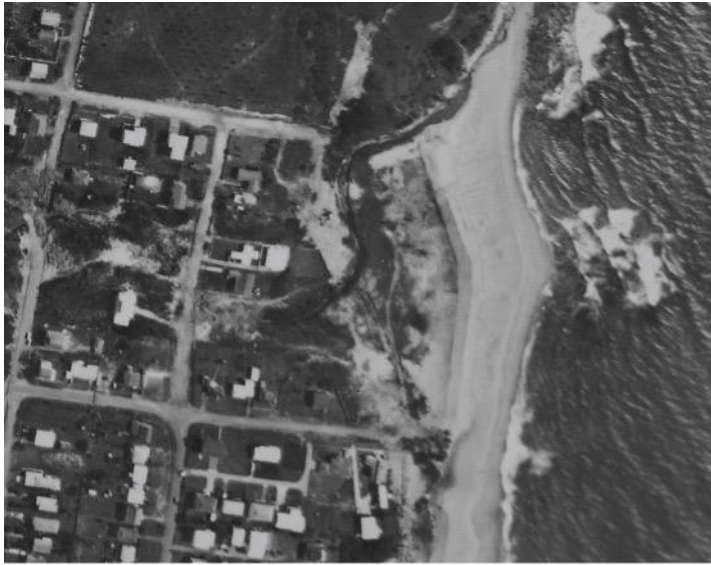
Figure 6: 1974 January, Aerial – North Shelly Beach

A dune has been artificially reconstructed

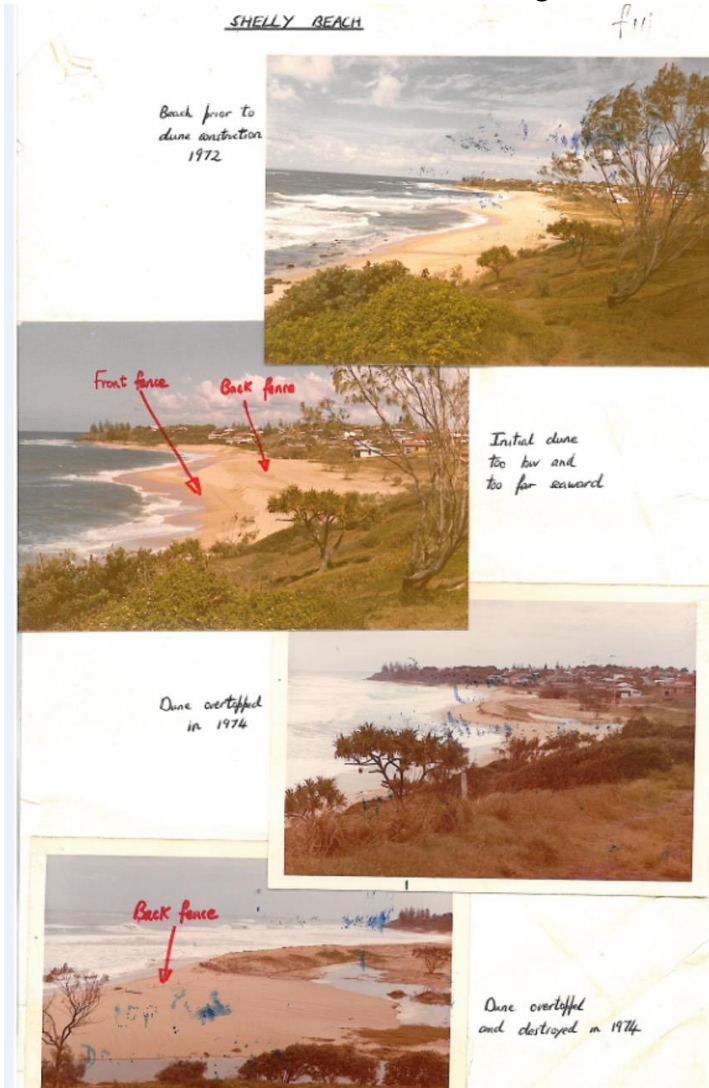
Figure 7: Imagery from the then Beach Protection Authority indicated dune severe sea erosion between 1972 to 1974 and damage to the January 1974 reconstructed dune above.

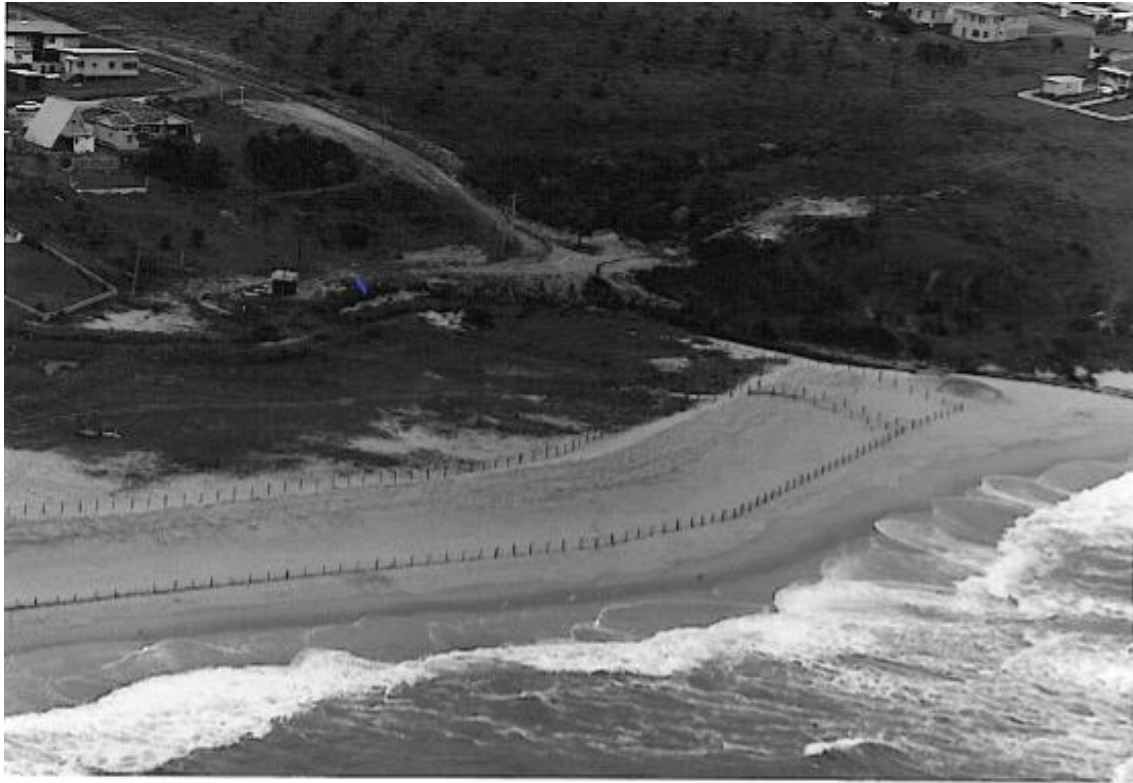
Figure 8: 1976 22 January, Aerial – North Shelly Beach

Beach Protection Authority imagery suggests the foredune was reconstructed again prior to January 1976 and revegetated.

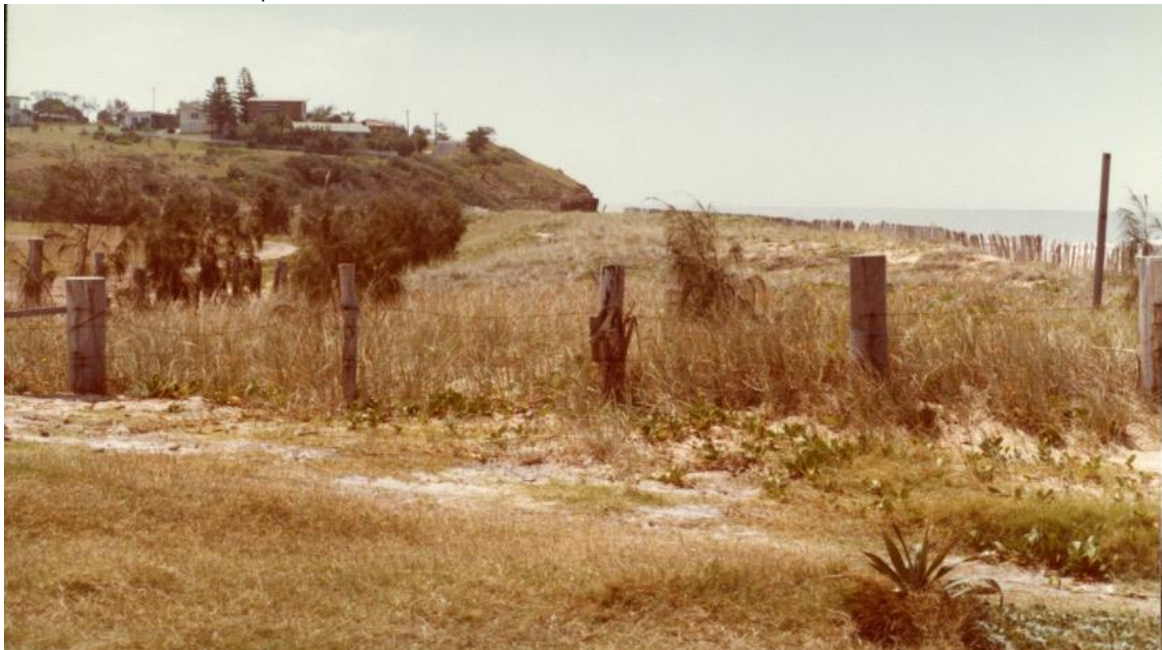
Figure 9: 18 September 1979

Foredune at Shelly Beach looks devoid of tree cover except for a few horsetail she-oak at the southern end which predated the works.

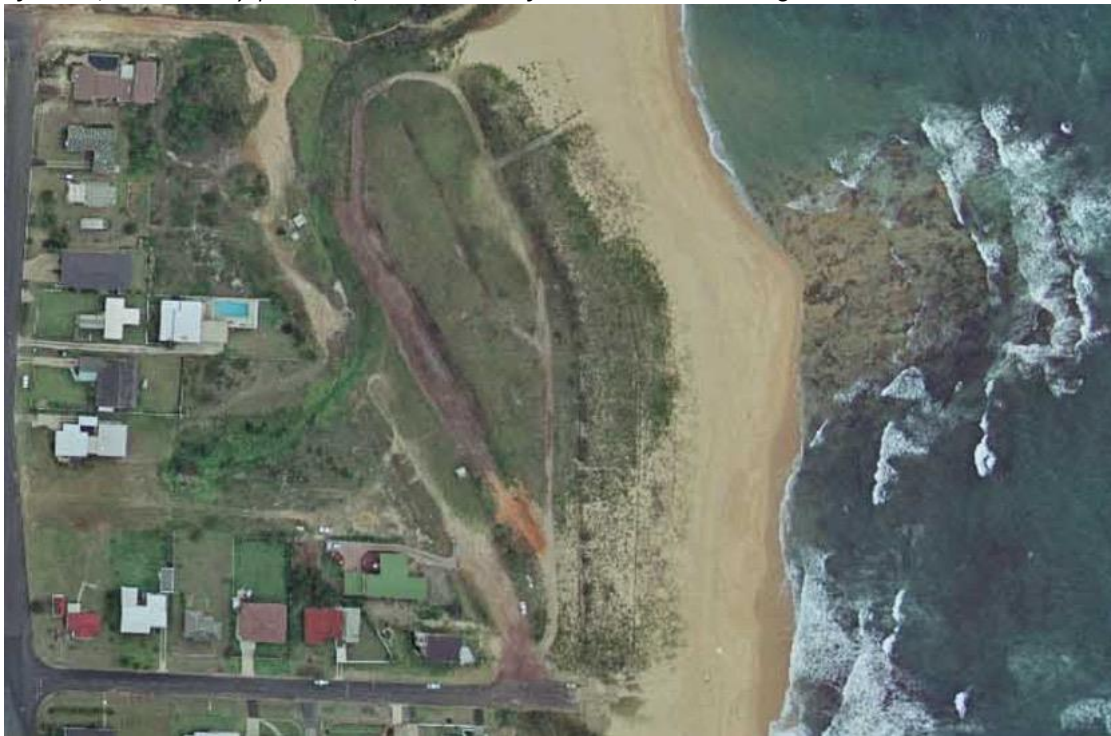
Figure 10: 1981 7 November

Aerial imagery confirms the dune is dominated by ground cover plant species with a single line of trees, most likely planted, at the rear of the dune becoming obvious.

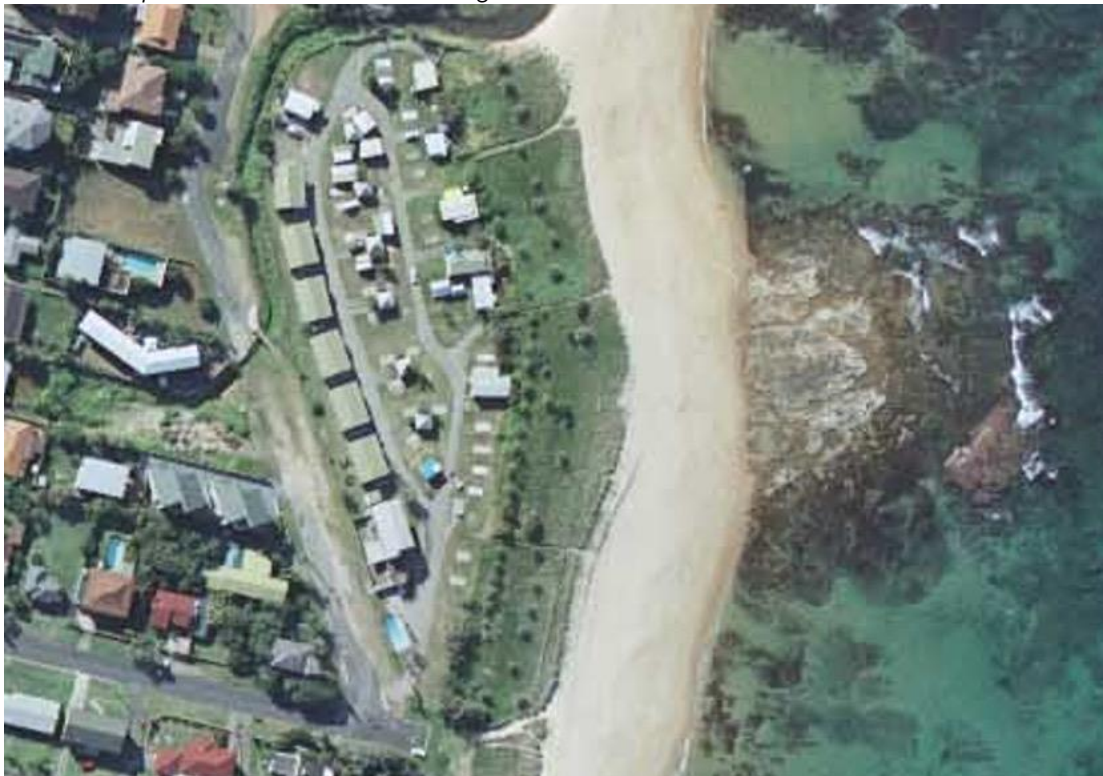
Figure 11: 1994 25 May

Trees have appeared seaward of the original line of trees at the rear. The uniform size, spacing and arrangement in lines suggests artificial planting. These may be the Cotton Trees. Clearing of trees in the northern part appears to have occurred. Additional trees appear to have been planted on the western edge

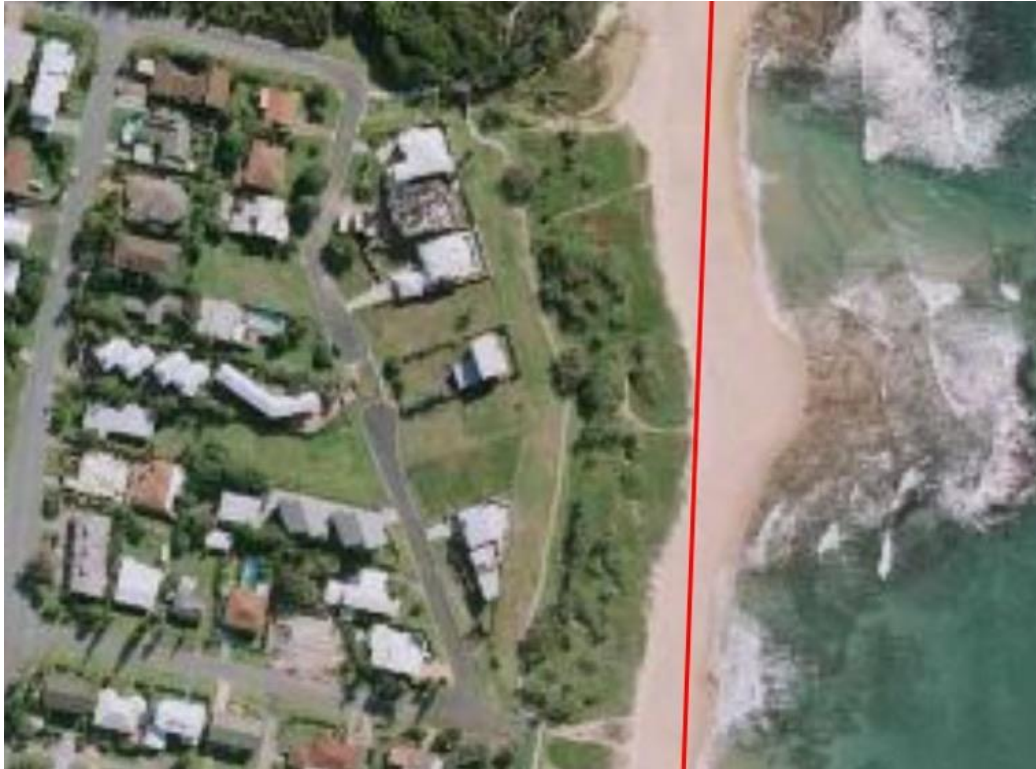
Figure 12: 2004 11 June

The new line of trees appear to be rapidly expanding, but mainly westward (probably due to exposure). It is therefore assumed that these are the current cotton trees. Ground truthing needed.

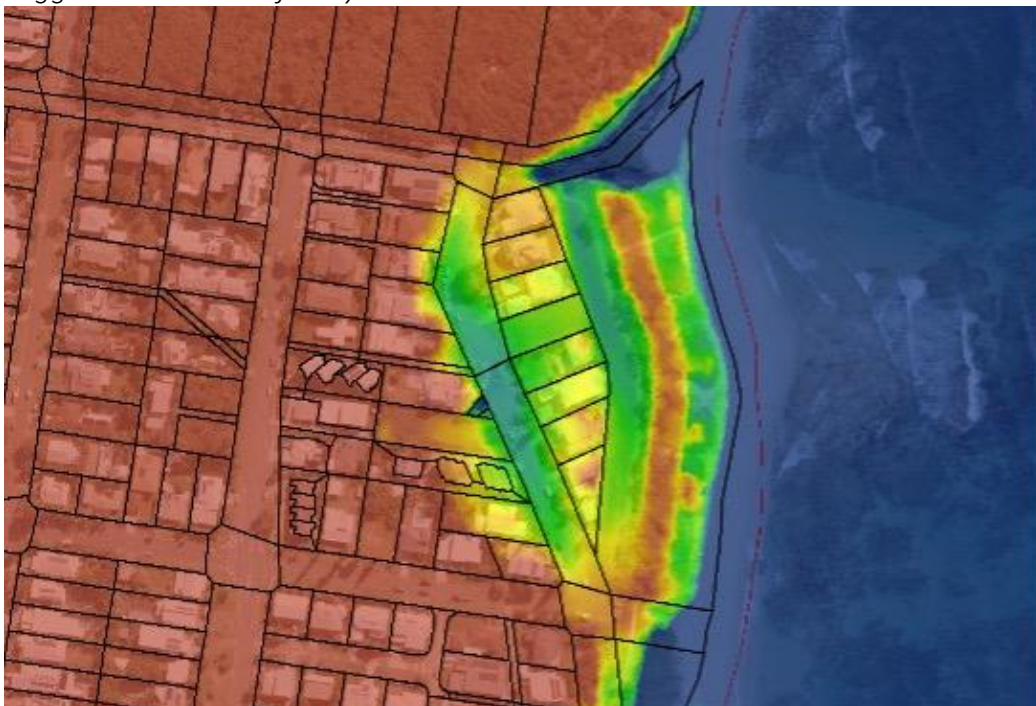
Figure 13: Circa 2011

Land elevations.

Suggest the 1976 artificially created dune is still intact.
