# WATSON PARK MANAGEMENT PLAN

**NOVEMBER 1994**

**WATSON PARK  
CALOUNDRA'S  
NATURAL HERITAGE  
PAST, PRESENT  
AND FUTURE**

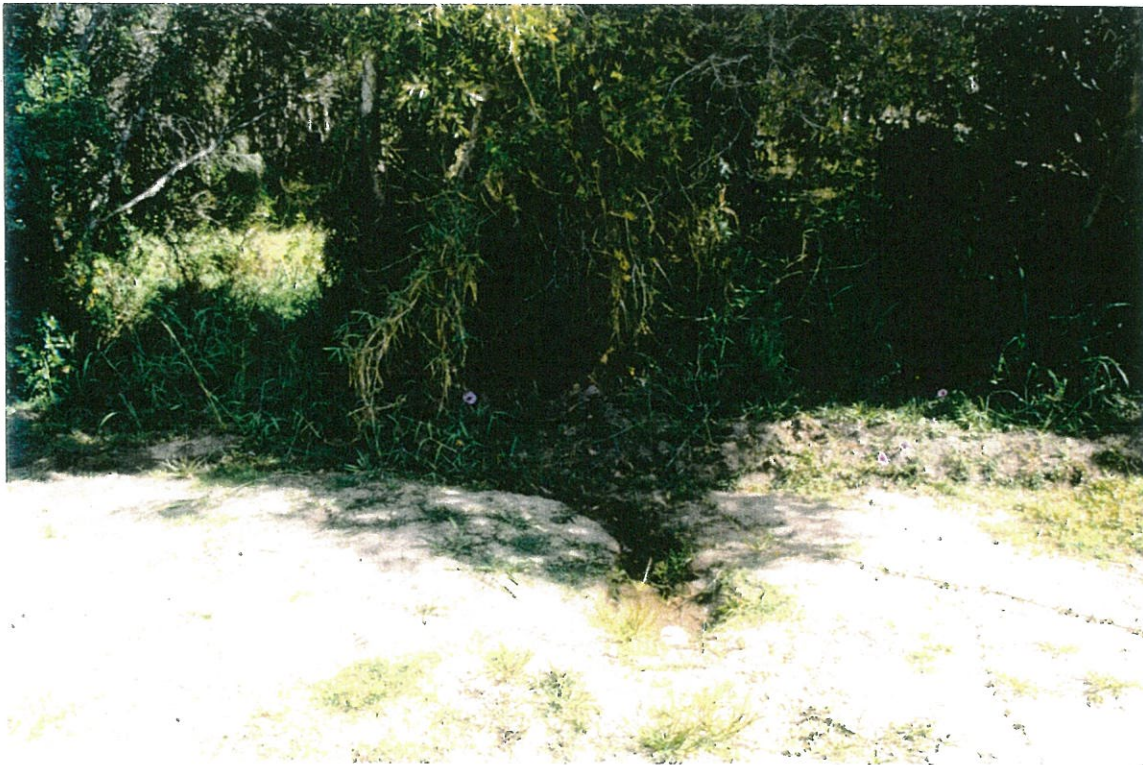
Units located in McIlwraith Street are discharging stormwater from pipes into Watson Park. After consultation with Caloundra City Council's Plumbing Department, it was discovered that approval has been given for the units to discharge stormwater in such a way. Walking tracks do become muddy during periods of rain, particularly in the northern end of the park. The altered drainage pattern (i.e. the runoff from units and houses being directed into the park) has also altered the native vegetation constituent of the park. As stated by Dr Olsen and Drane (refer to appendix) Melaleuca quinquinervia seems to be colonising in areas that were dominantly Eucalypt communities.

*Figure 8- Erosion and weeds flourishing near the drain outlet.*

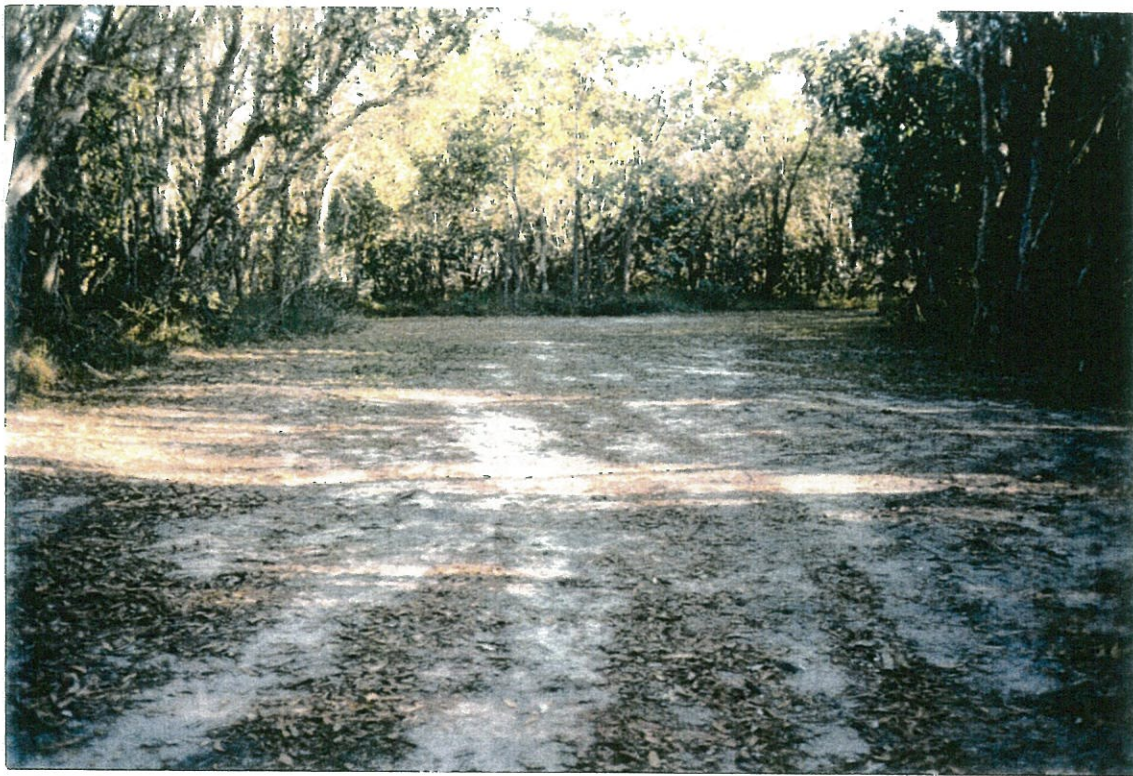
The large number of tracks currently existing in Watson park does pose a problem in that they segment the park to such a large degree that it creates a 'lost and insecure' feeling to park users. The large number of tracks also causes greater impact on the environment and as future visitor numbers increase, trampling of vegetation and erosion will increase. The segregation also inhibits the ability for fauna to survive in such areas as it decreases habitats and increases disturbance to remaining habitats.

*Figure 9 - Excessive track widths leave the land barren and open to erosion (1991 photo).*

- It is proposed that 'Friends of Watson Park' define and harden tracks by using a mixture of materials such as road base bark and concrete and line where appropriate with small rocks or log edges, and a timber board walk be erected over the muddy section of track.
- Tracks that need to be closed are revegetated with natural endemic flora and fenced.
- A proposed circuit track system is shown on Map 4.
- Tracks are to be a standard of 2 metres in width as stated in the Australian Walking Track Manual.

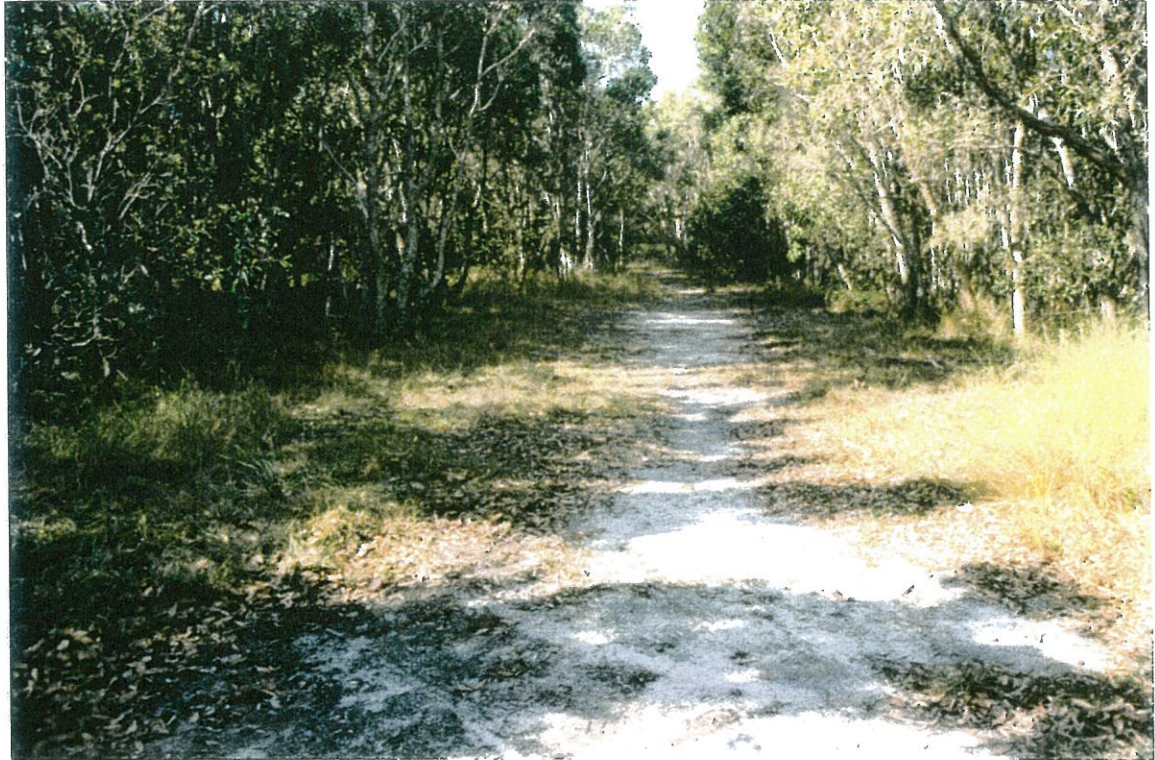
*Figure 10 - Track widths of approximately 2 metres decreases the possibility of erosion occurring (1994 photo of the same track as in Figure 9).*

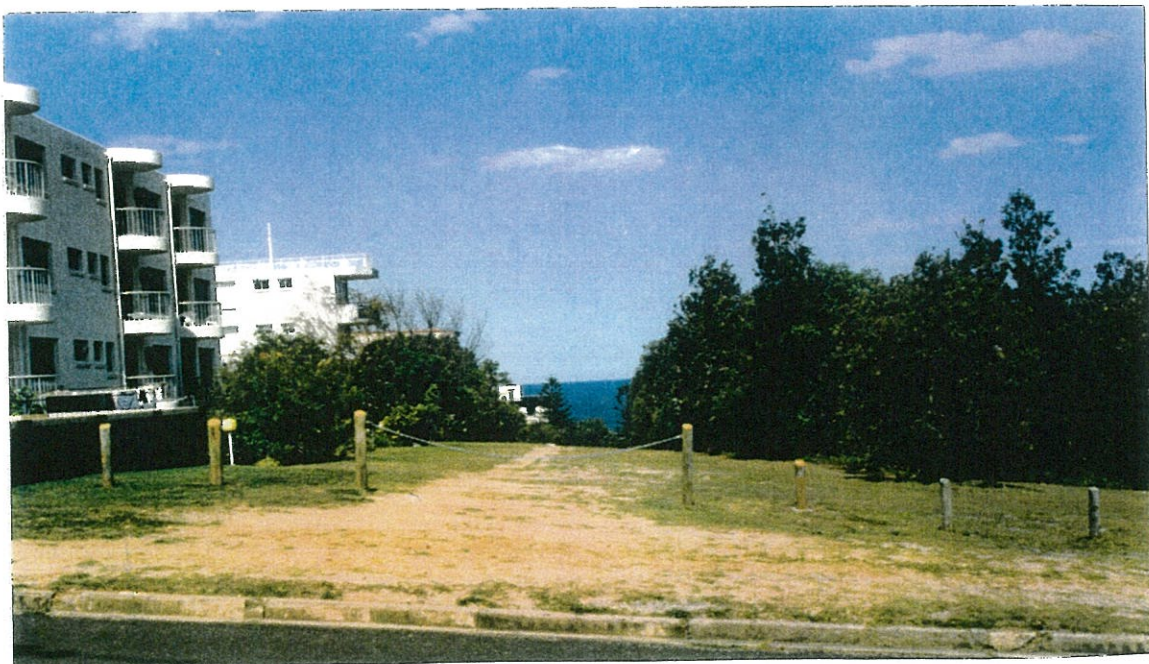
- The circuit track would provide access to large areas of park in the event of any fire. Also any fire in the area would be easily contained as the park is boarded by roads and the fire access easement. The close locality of water mains (as shown on map 2) will also alleviate the degree and intensity of any fire.

*Figure 11 - More than adequate fire access adjacent to housing.*

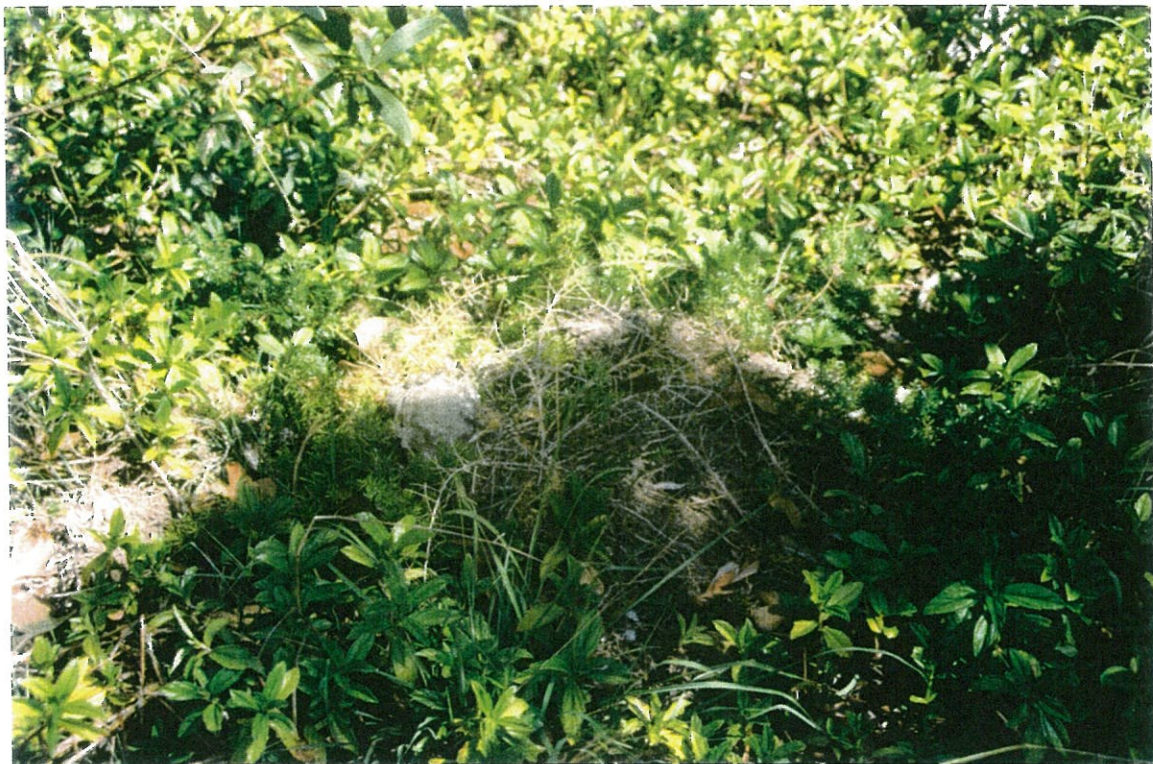
A number of weeds are present in Watson Park and are listed in Table 1. Dr Olsen and Drane (refer to appendix) have stated that "some of the weeds that are presently seen in this vegetation type are of concern for the future integrity of this community". The weeds displace native vegetation and therefore have the ability to alter the natural attributes of the park.

*Figure 12 - Dumping of garden rubbish into the park introduces weeds e.g. Singapore Daisy.*
