Zones 3C and 3D South Shelly Beach

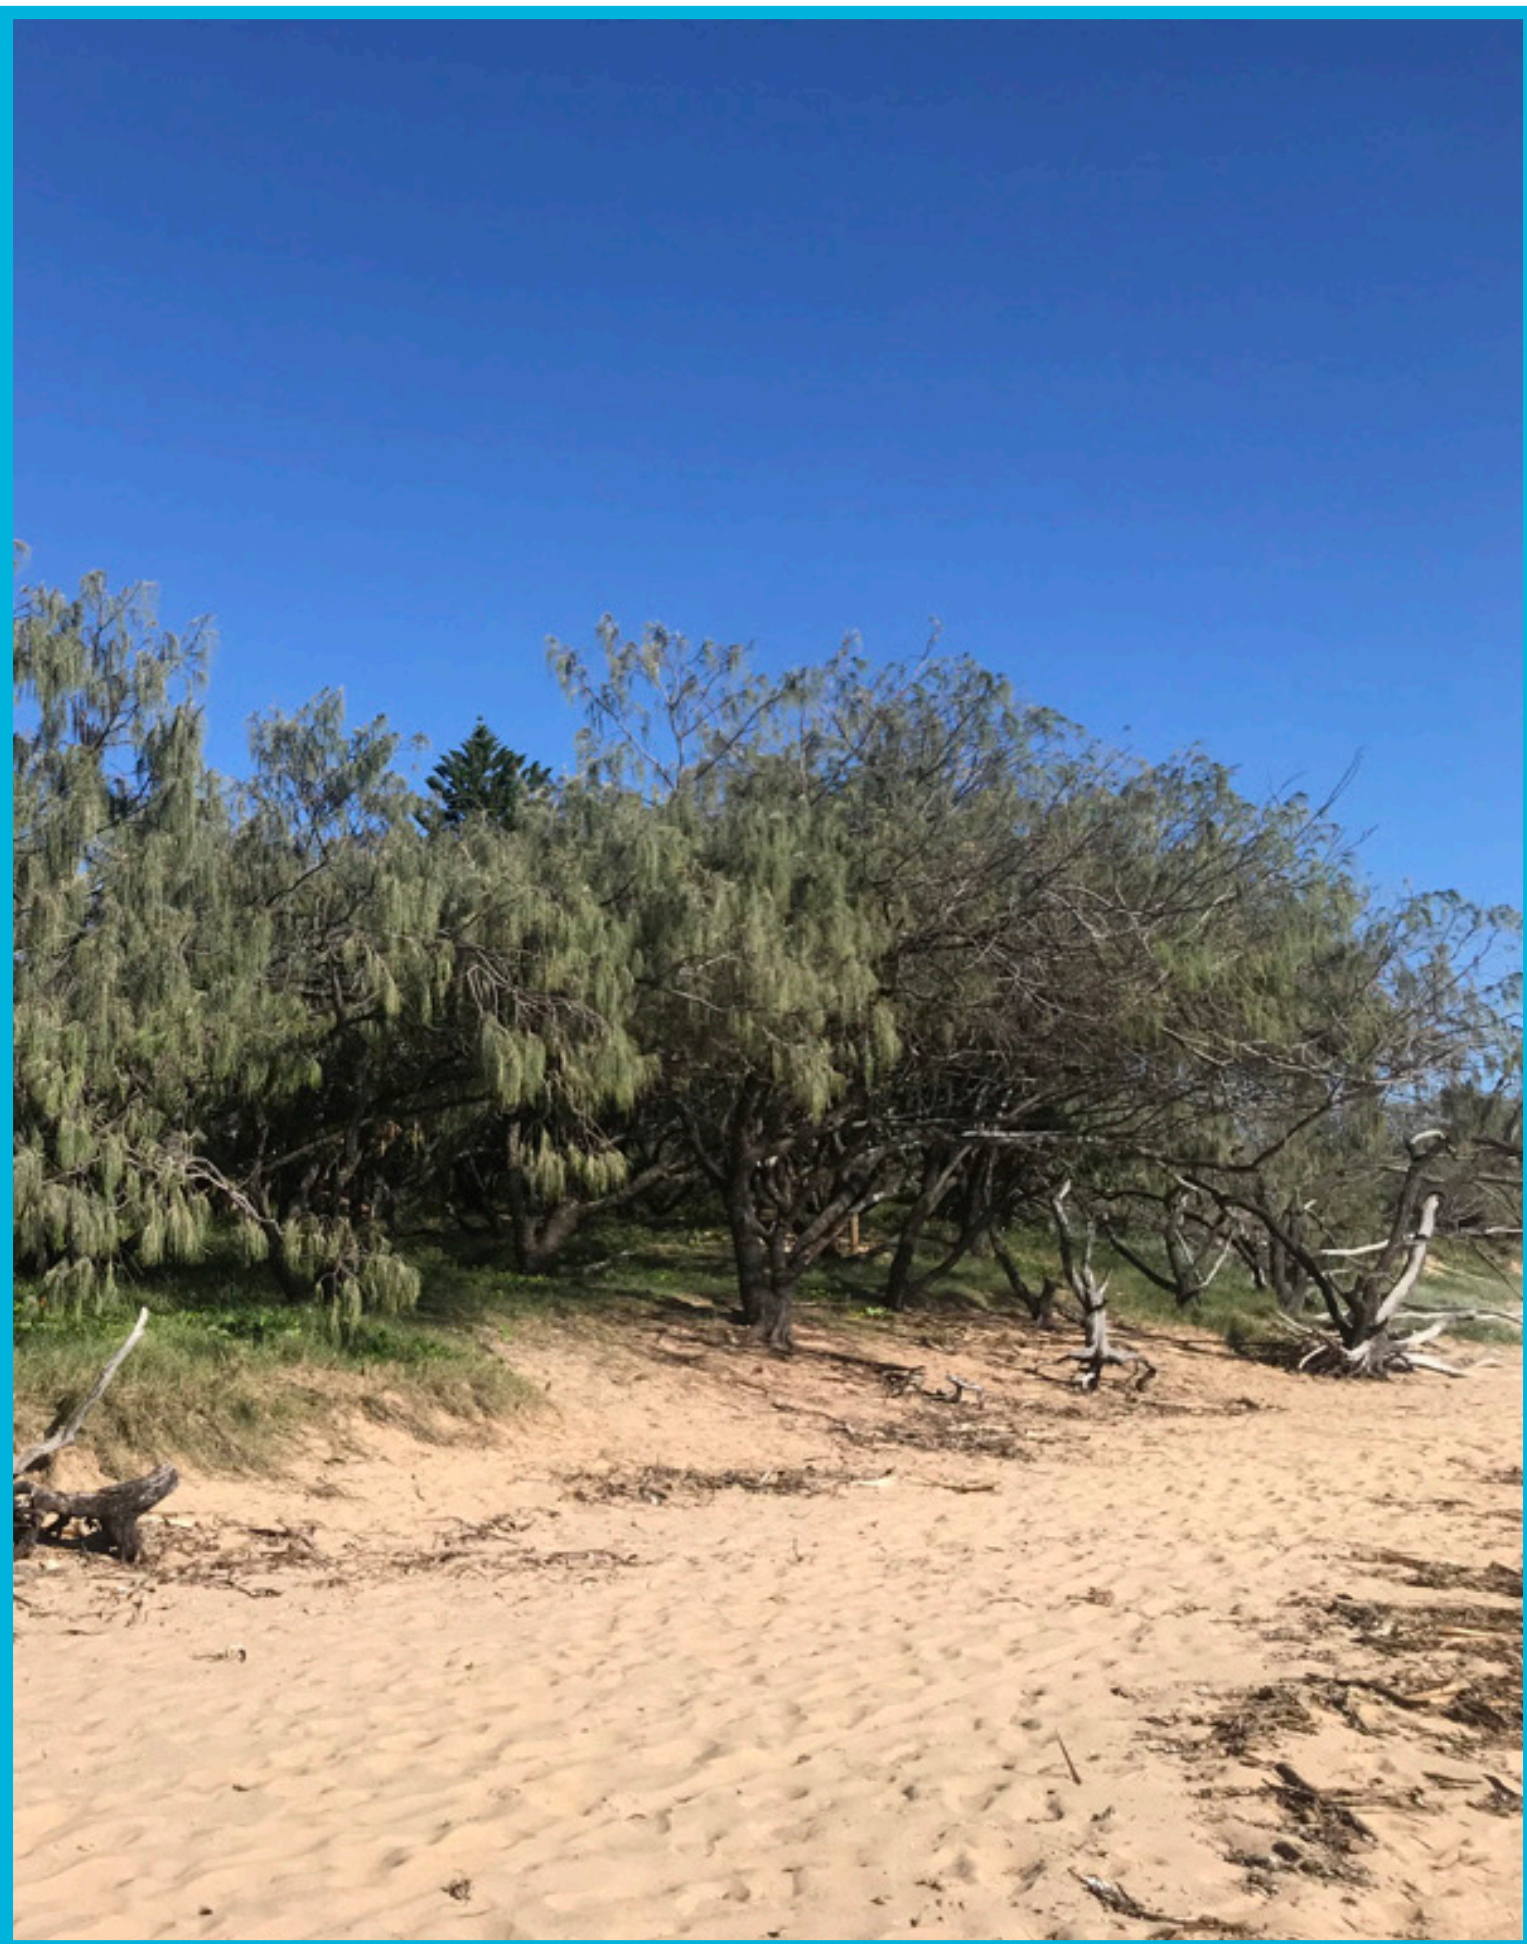
Rock shelves off South Shelly Beach

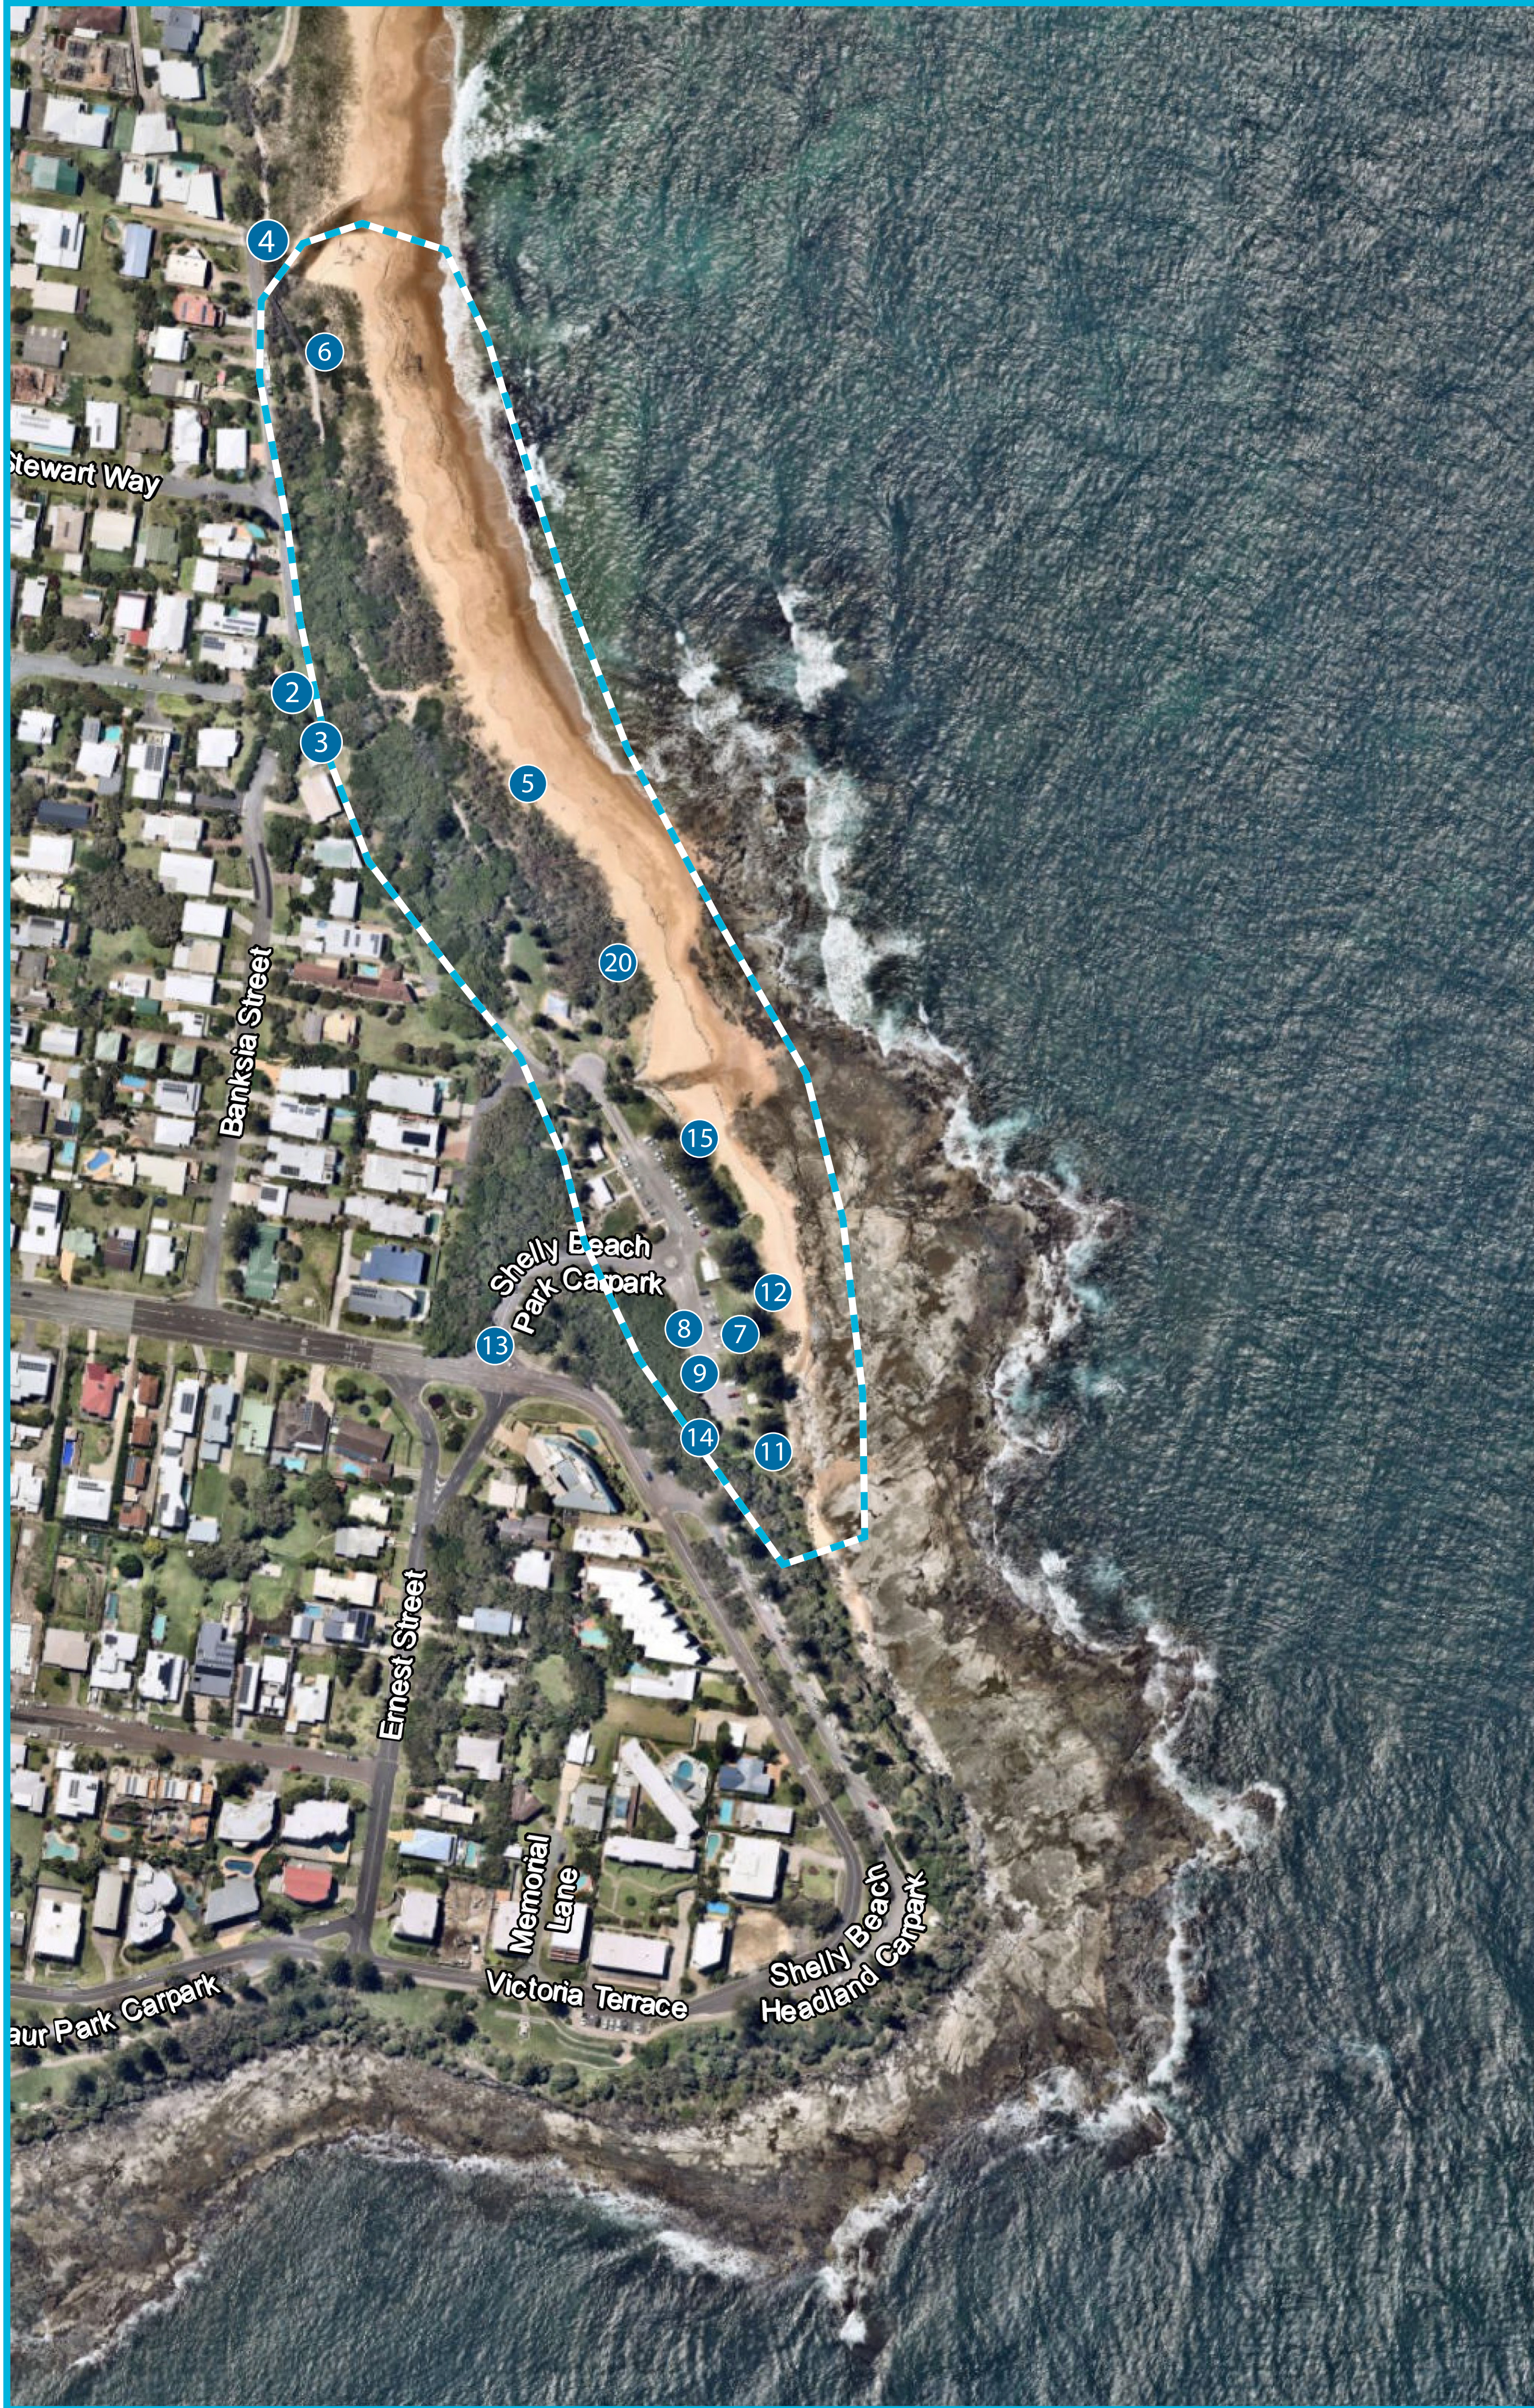
Dune vegetation, South Shelly Beach

› Encroachment of marine couch grass on lower dune restricting turtle nesting.	5 › Manual removal and annual maintenance of marine couch grass growing from high tide mark to remove physical restrictions to turtle nesting.		
› Weeds impacting on the ecological value of the dune.	6 › Undertake spinifex planting to stabilise areas following removal of marine couch		
› Overnight camping.	7 › Maintain regulated parking controls to manage overnight camping.		
› Informal (illegal) Parking – adjacent embankment in south-west corner of Shelly Beach Park car park	8 › Install bollards along road alignment in the south-western corner of the Victoria Terrace car park to restrict informal parking.		
› Vegetation management on embankment in south-west corner of Shelly Beach car park.	9 › Prune Cottonwoods back by approx. 5m from bollards / road edge, and undertake infill plantings	10 › Retain balance of existing vegetation on slope to support bank stabilisation in this area.
