Zone 3B - North Shelly Beach

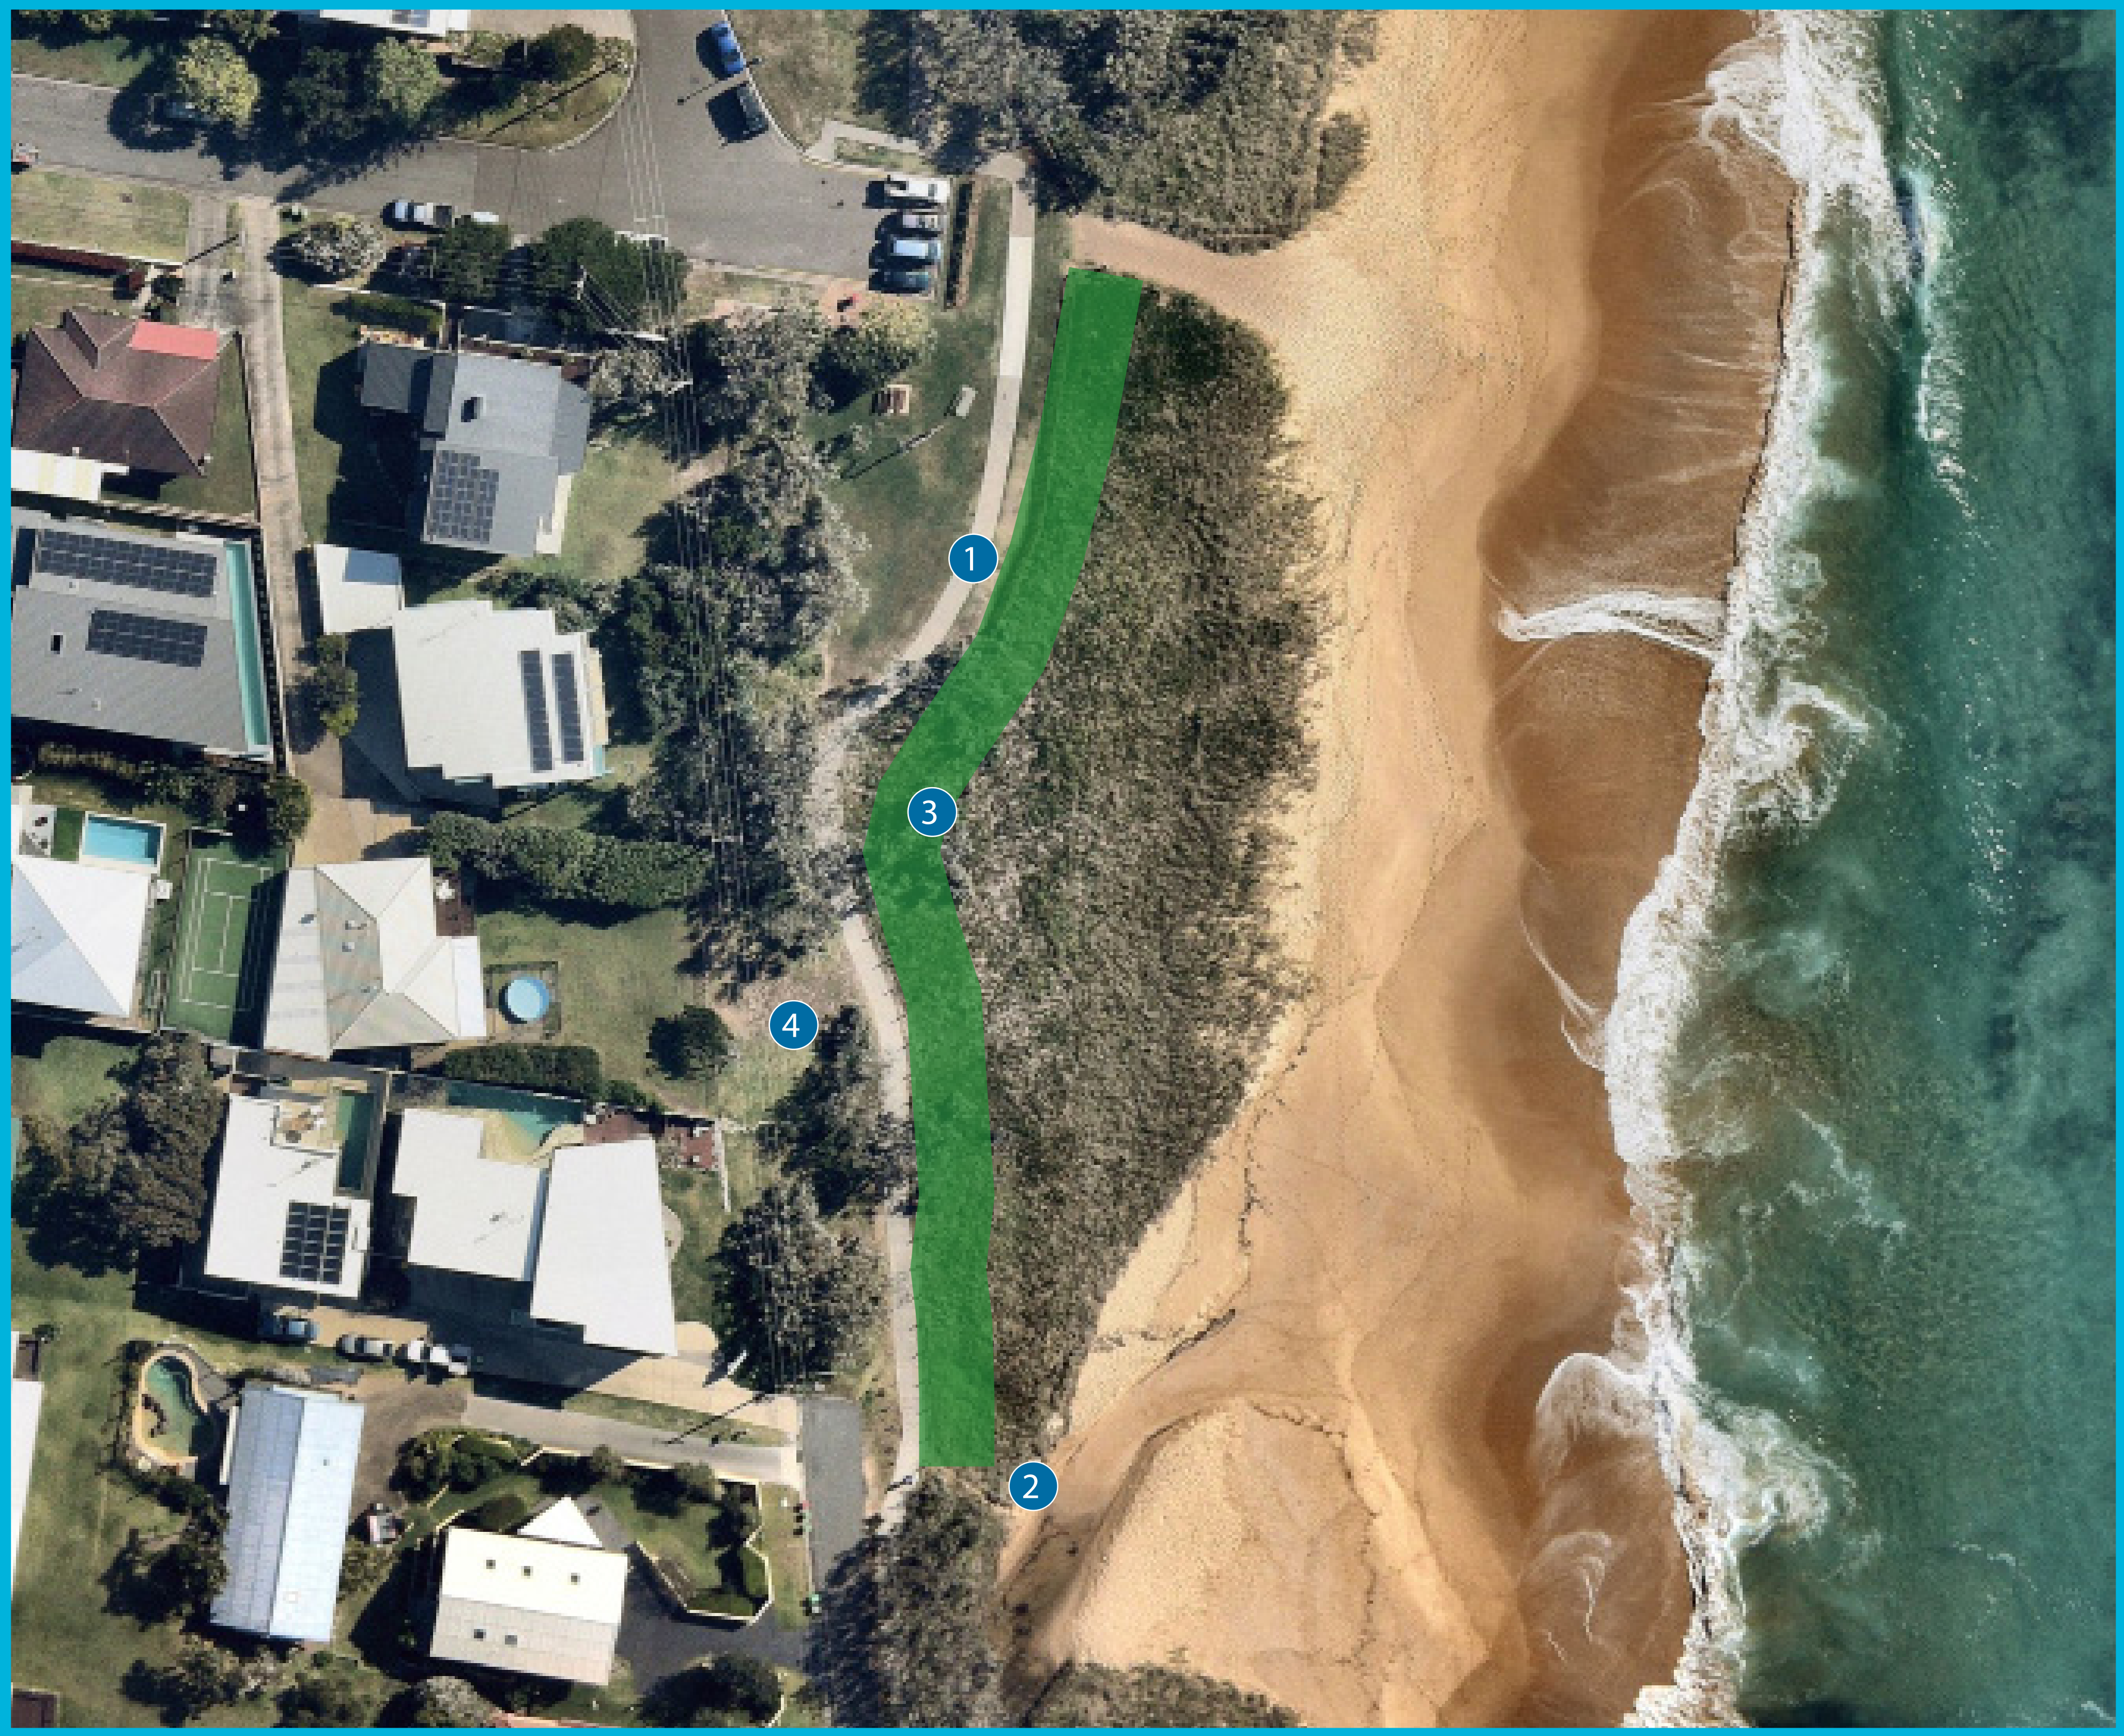
| <div>Public views of the beach / ocean from the coastal path between William Street and the Creek / drain at northern end of Victoria Terrace highly valued as part of the coastal path experience.</div> <div>1</div> | <div>Maintain filtered views of the beach / ocean from the coastal path between William Street and the Creek / drain at northern end of Victoria Terrace.</div> <div>1</div> | |
| <div>Storm and coastal erosion events impacting on the creek/ drain at the northern end of Victoria Terrace with the risk of significant erosion into the open spinifex dune area directly north of the drain.</div> <div>2</div> | <div>Maintain cyclical / event based regime of maintenance works to rectify erosion at the creek/ drain located at the northern end of Victoria Terrace, Shelly Beach.</div> <div>2</div> | |
| <div>Open Spinifex coastal dune lacking overstorey vegetation to provide greater levels of dune stabilisation.</div> | | <div>Establishment of open /sparse plantings of Casuarina, Banksia and Pandanus from the fence line east to the mid-point on the dune. Planting to support dune stabilisation and contribute to light spill management. Spacings to allow for filtered views to the beach and ocean from the coastal path.</div> <div>3</div> |
| <div>Unapproved management (mowing) of public land on western side of coastal path.</div> | <div>Mowing / maintenance of the public open space to be undertaken by and in accordance with Council approved levels of service.</div> <div>4</div> | |
| <div>Vegetation (trees) reaching senescence, being removed, and not replaced from public open space.</div> | <div>Public open space vegetation / tree management regime to ensure replacement program of trees / vegetation to ensure retention of public amenity and shade.</div> <div>5</div> | |

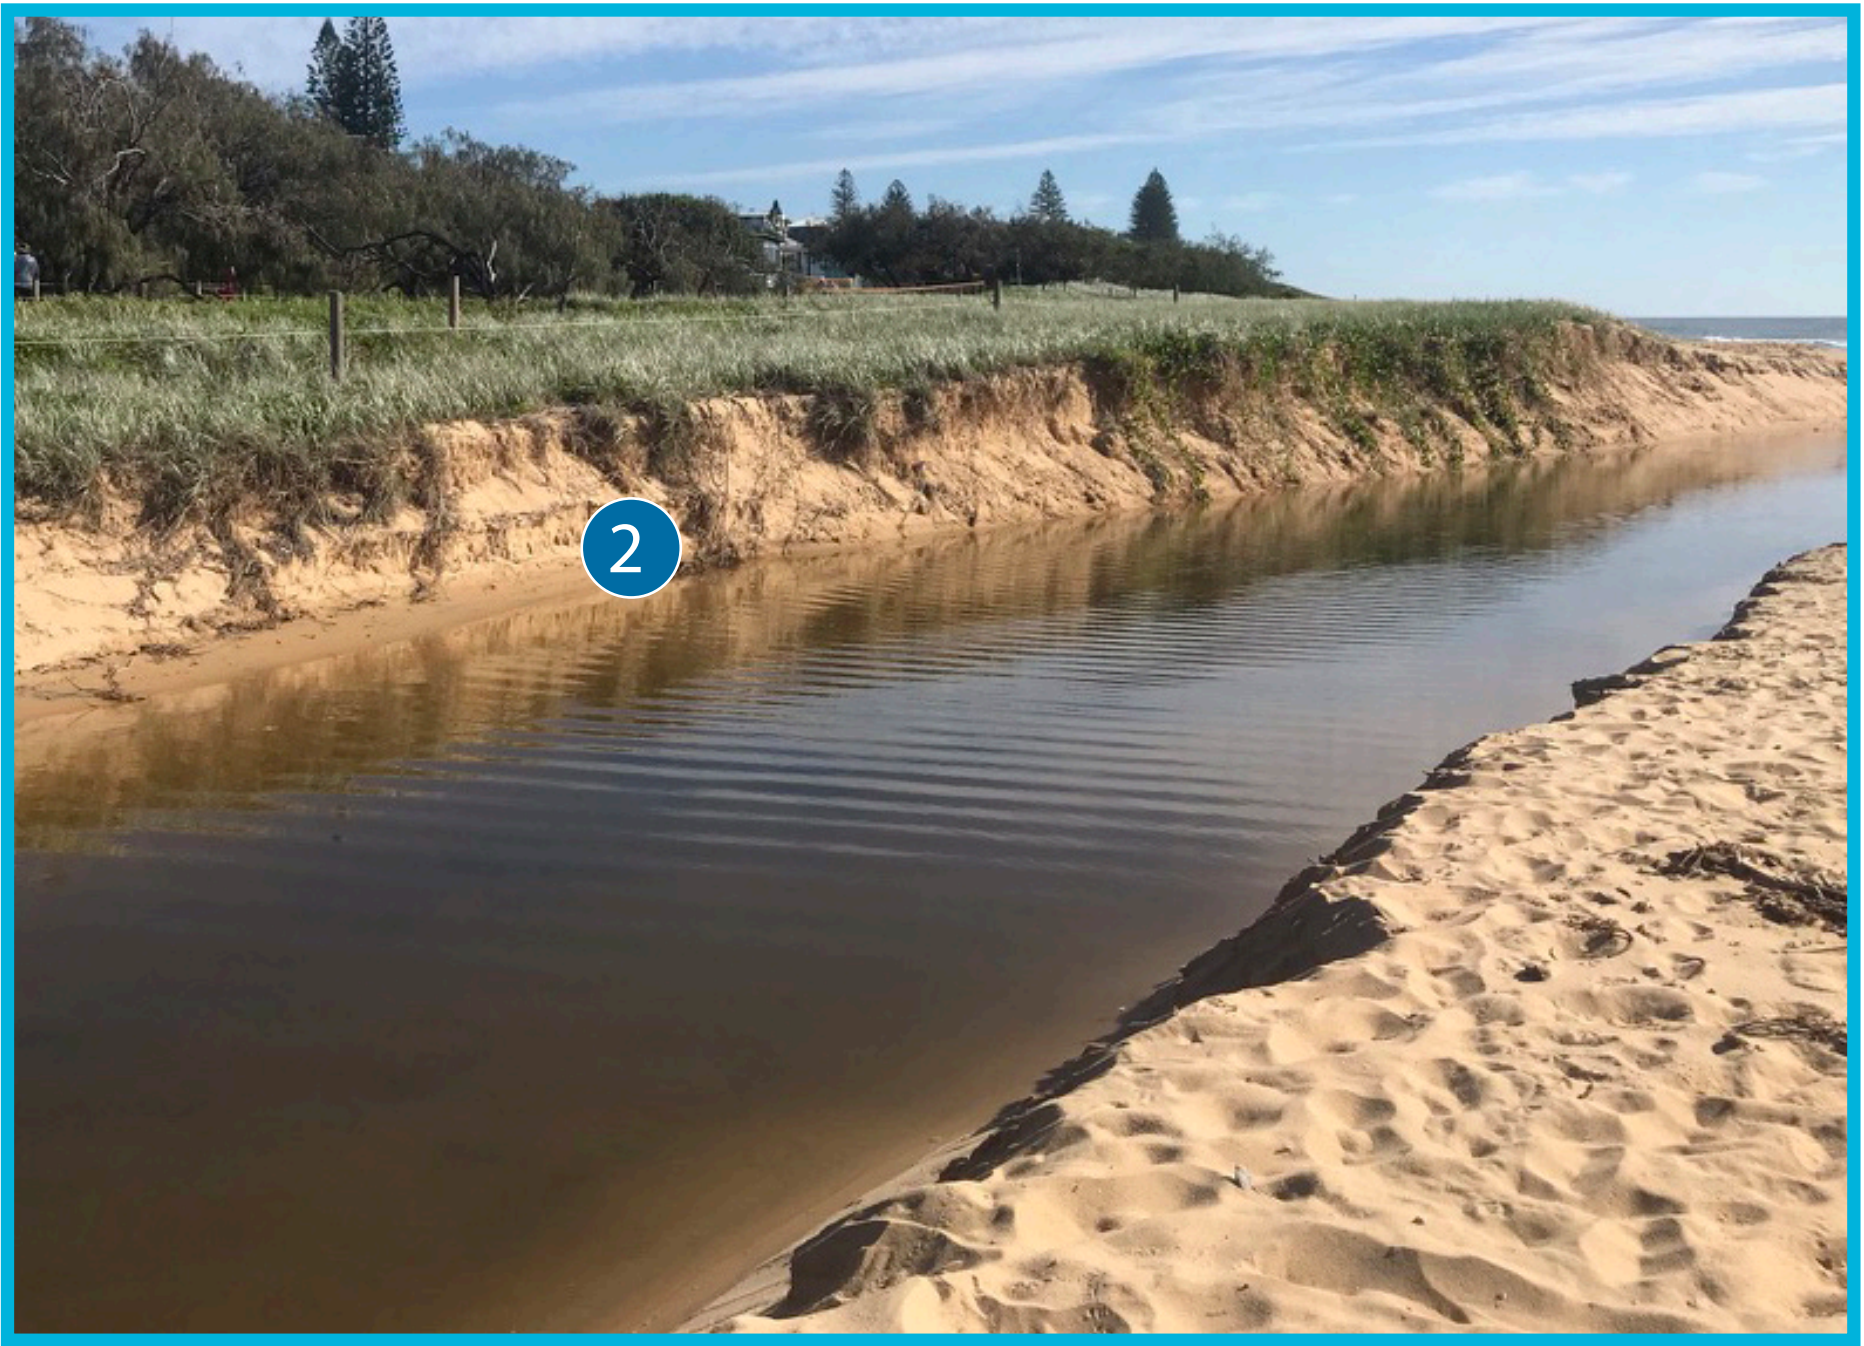
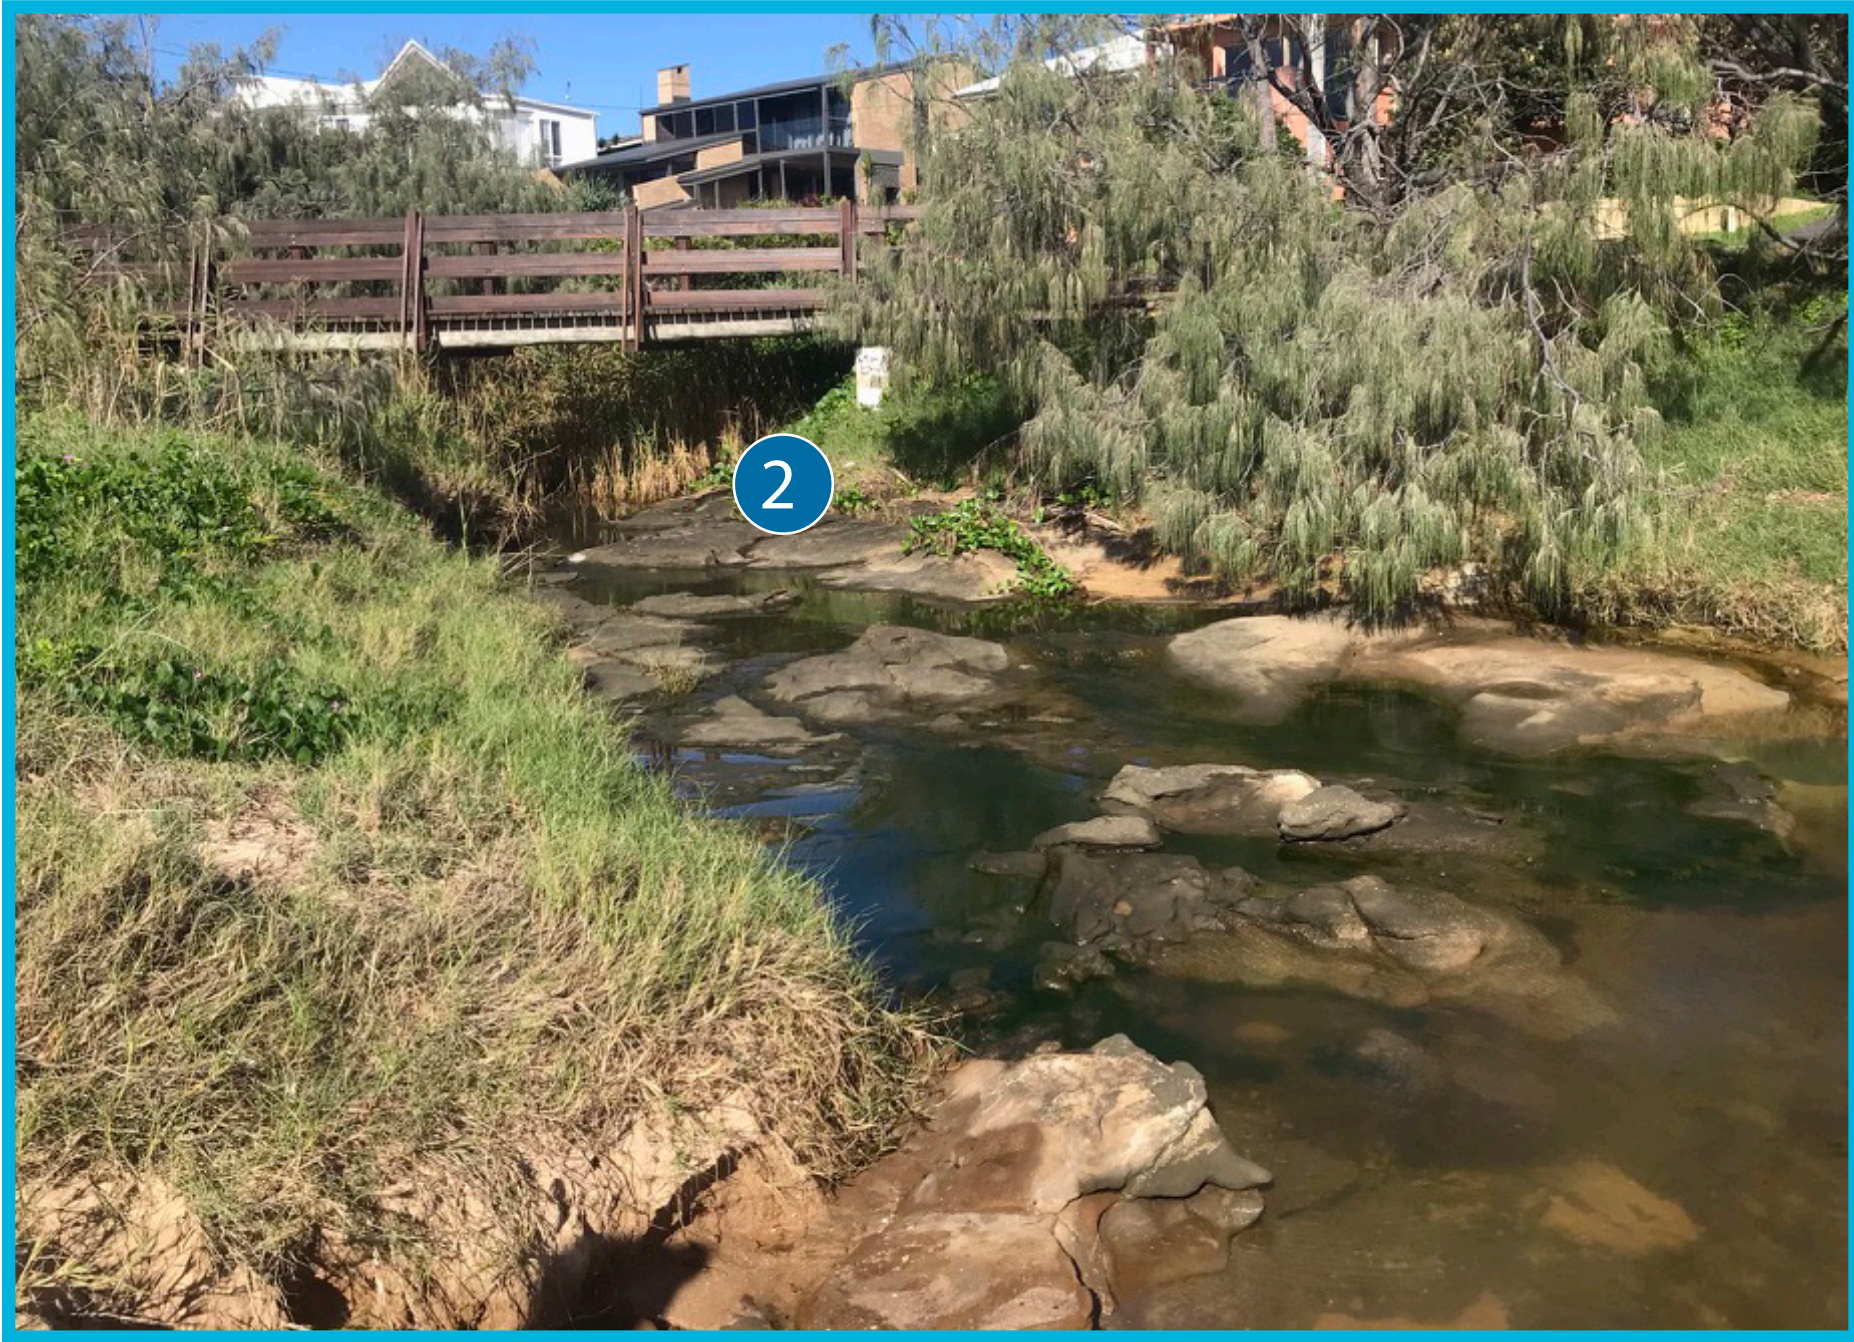
Creek/drain at the northern end of Victoria Terrace
