Zone 3A - North Shelly Beach (William Street Car Park)

Current conditions - Issues and Opportunities

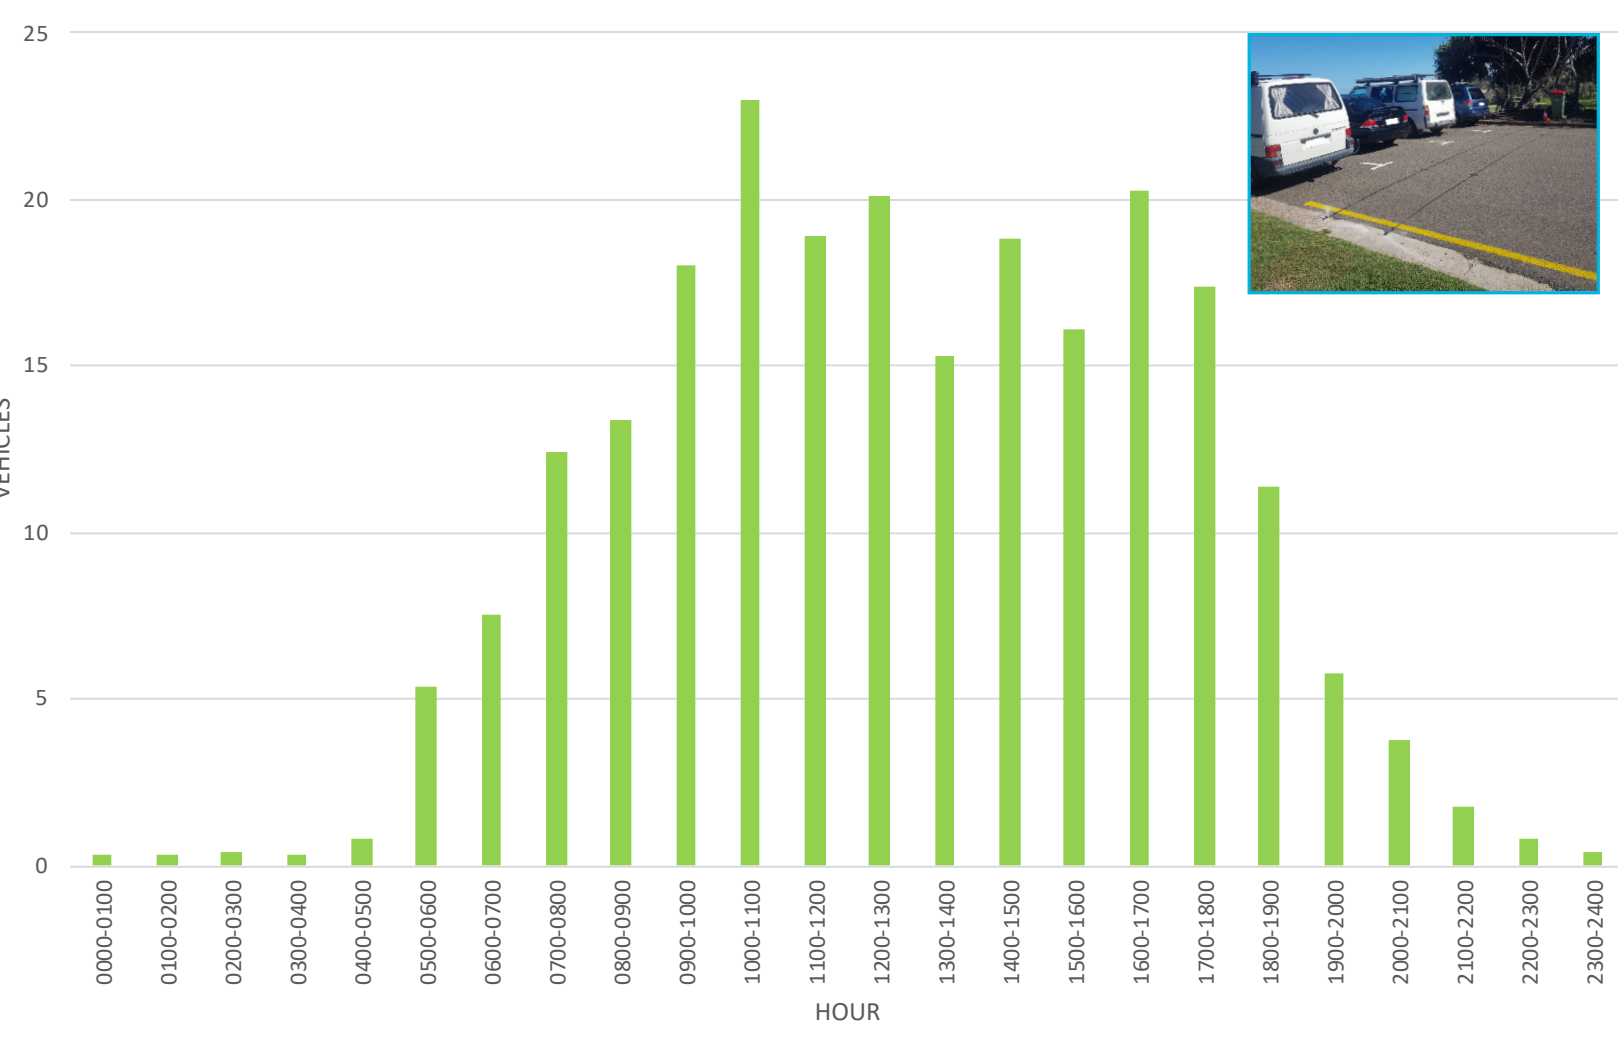
William Street Vehicle Movements - February 2021

- › The traffic counter detected an average of 87 vehicles/ day eastbound, into the bays.
- › The majority of vehicle movements occurred between 5am and 8pm.
- › From 8pm onwards the counter detected less than 2 vehicle movements per hour.
- › The Department of Environment and Science advice is that the majority of turtle hatchlings emerge from approx. 8pm onwards.

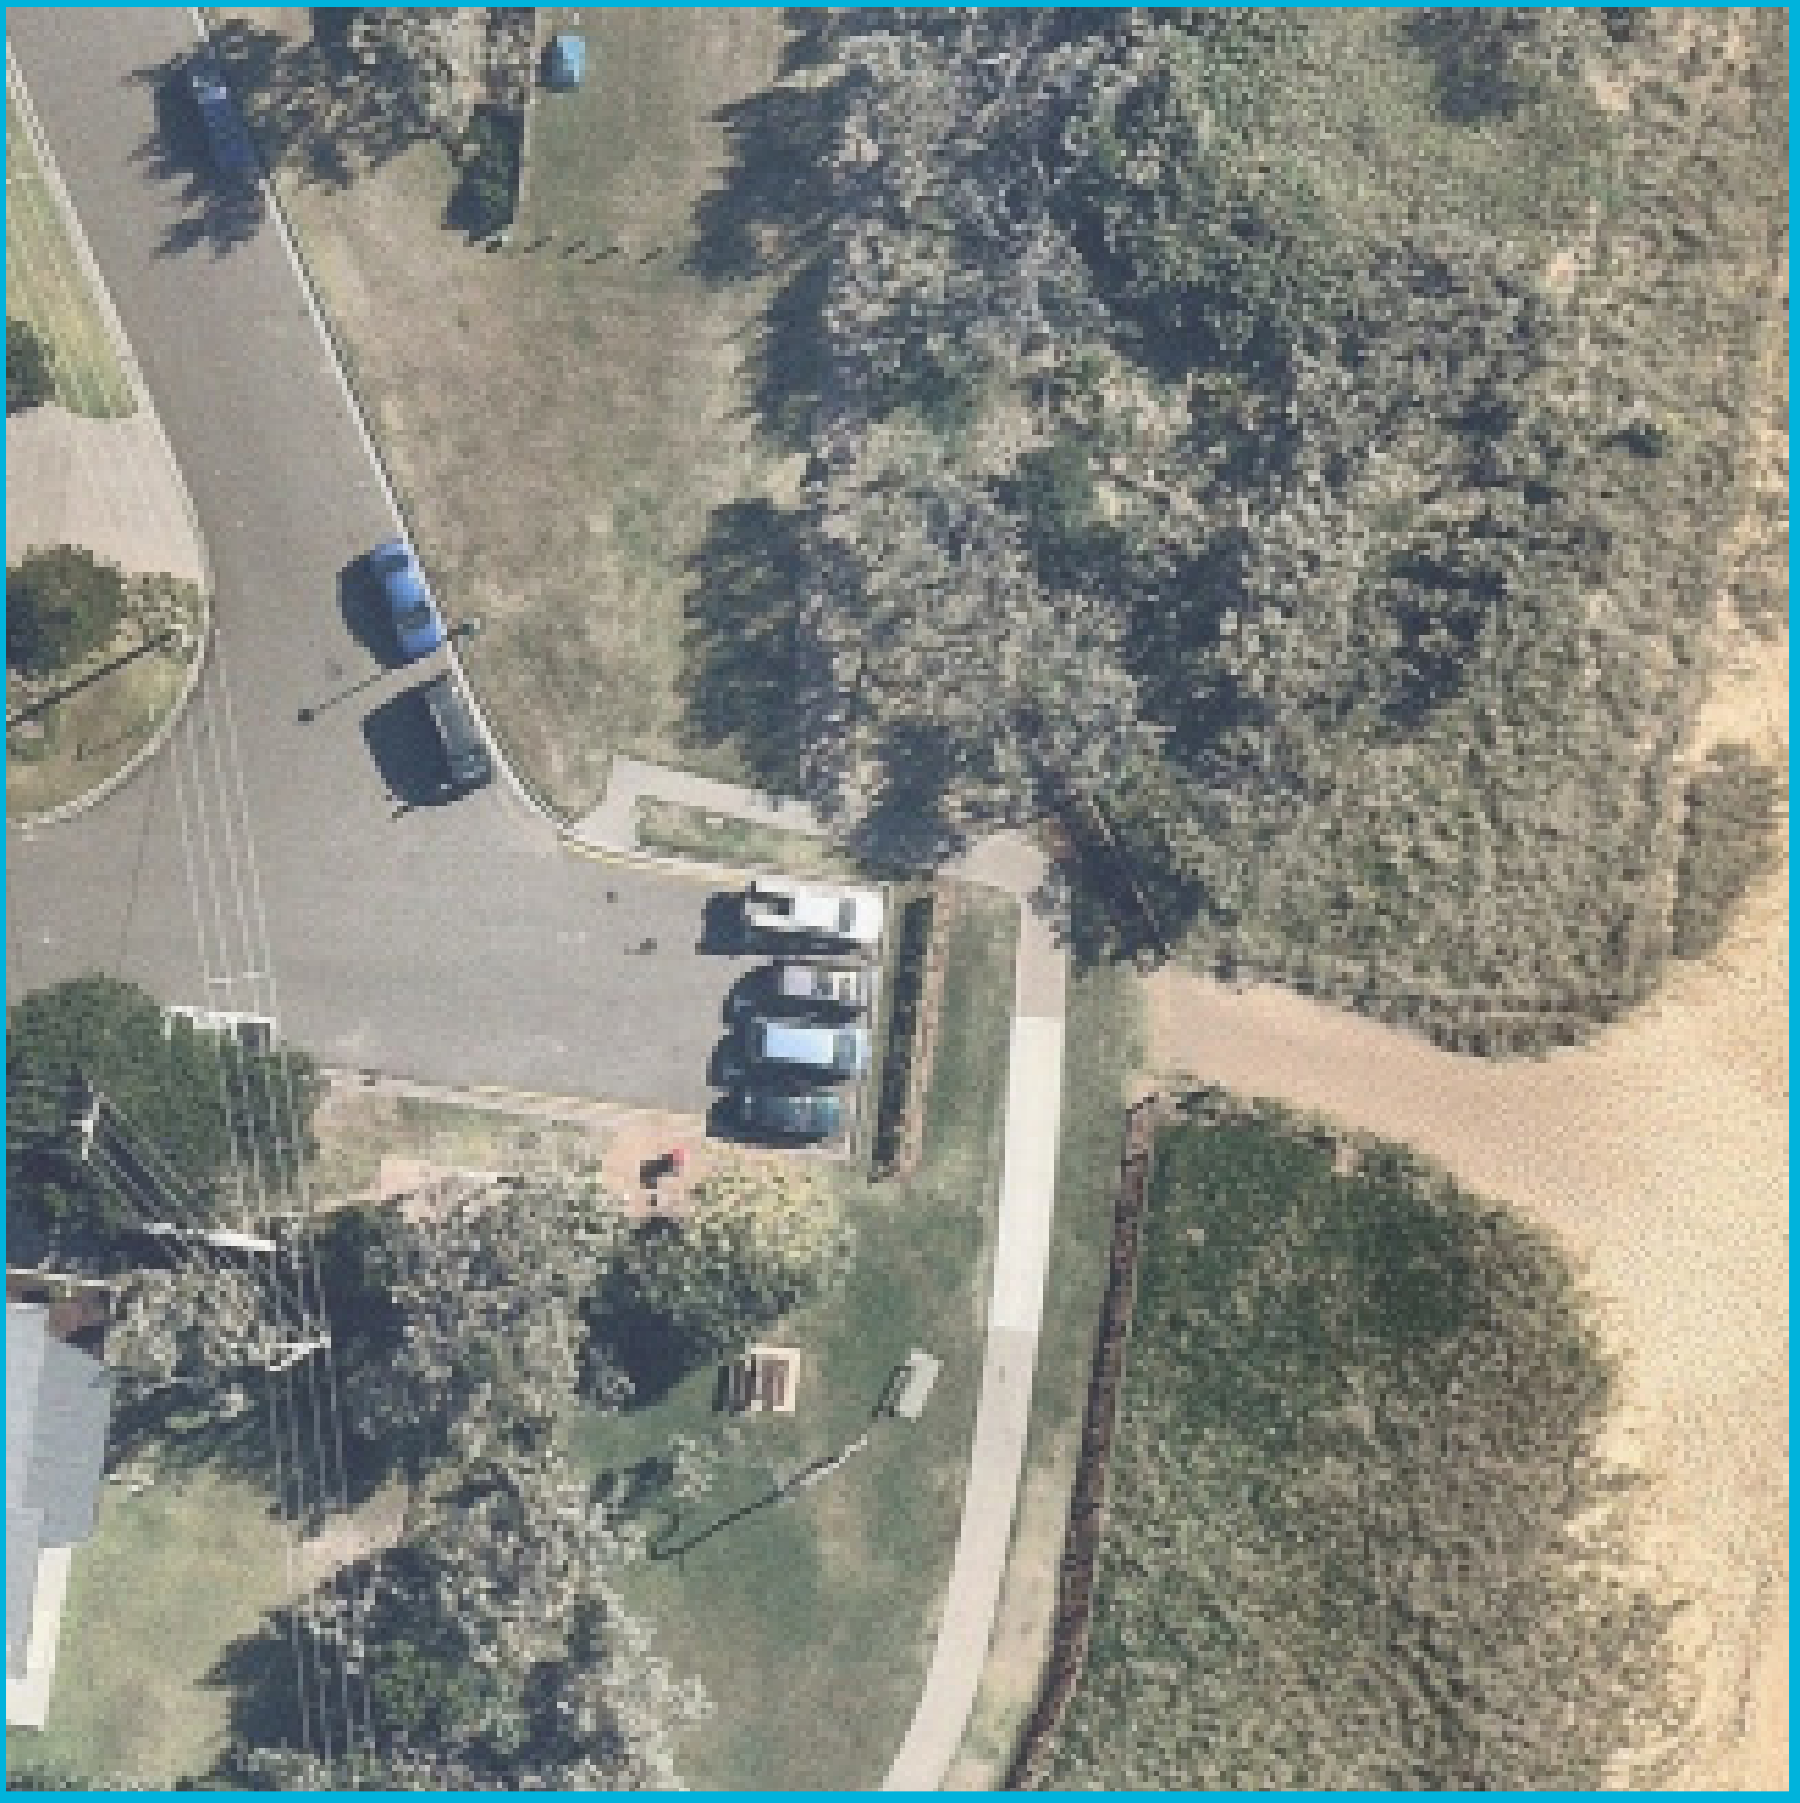
Option 1 - Retain and regulate

Option 1.1 - No change

- › Leave current parking area and management as is.

Option 1.2 - Regulate Parking

- › Regulate William Street car park.
- › Enforce as a no parking zone between the hours of 8pm and 4am during the turtle nesting season.

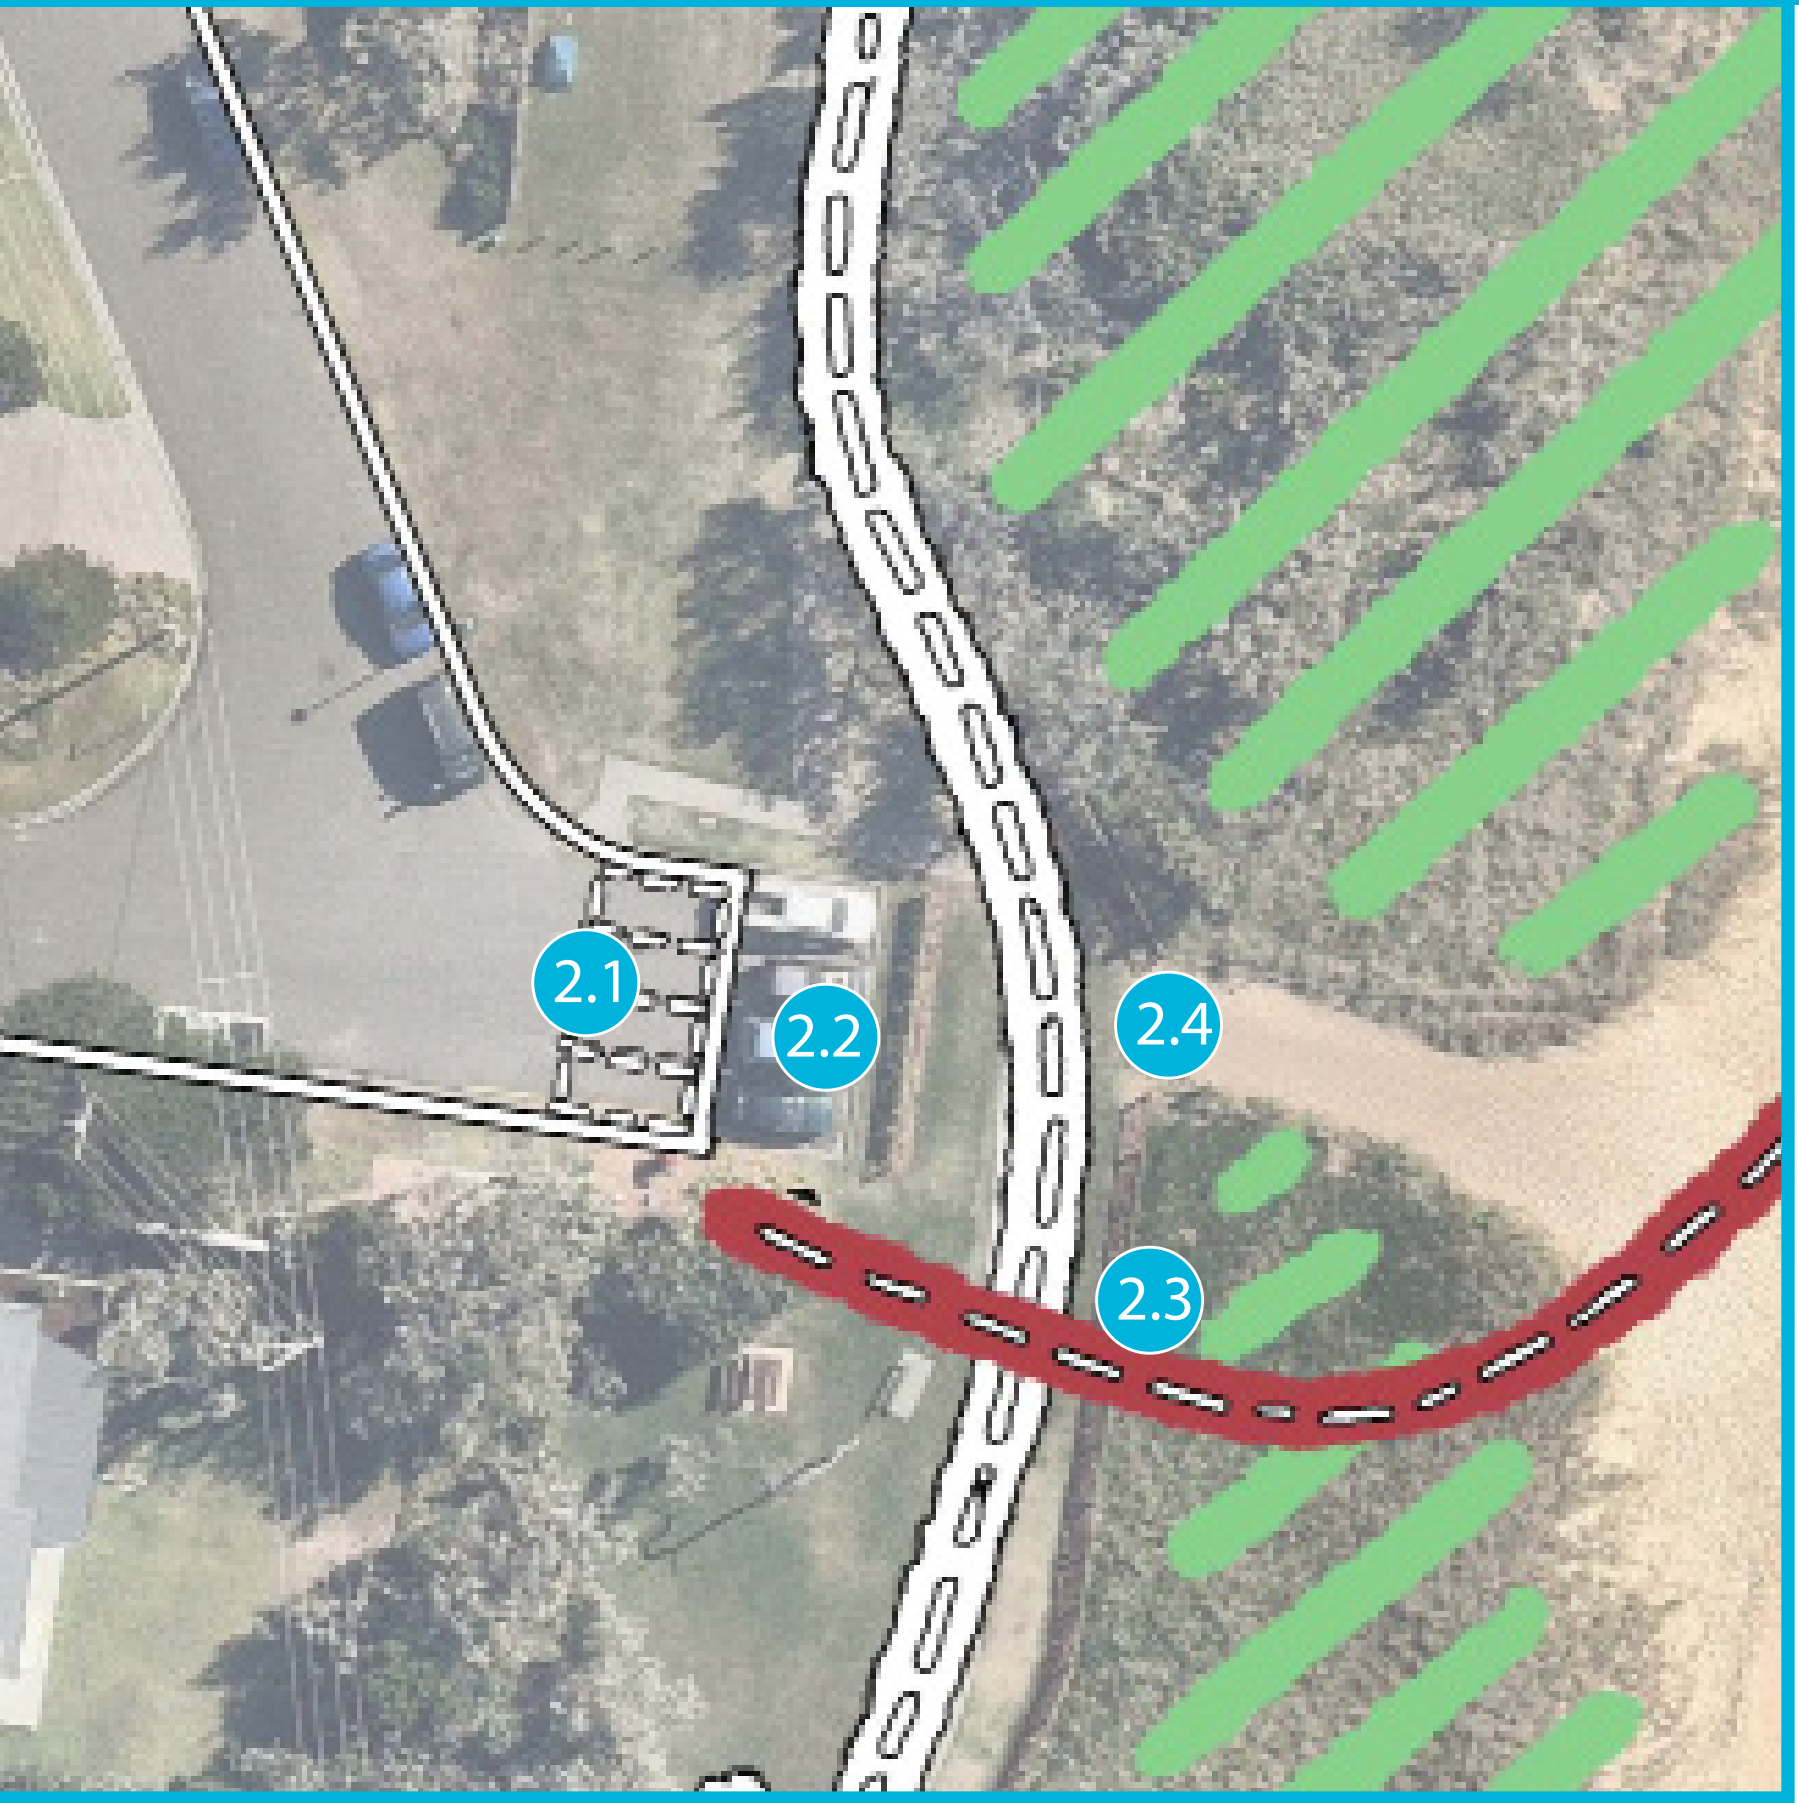
Option 2 - Move parking 5m west

- 2.1 Move existing parking spaces 5m west.
- 2.2 Reclaim balance area of current car park and utilise as enhanced public open space.
- 2.3 Re-align beach access to face east and then north to provide shelter from the south-easterly breezes and contribute to reduction of direct light spill from adjacent road network onto the beach.
- 2.4 Undertake appropriate dune planting to contribute to light spill reduction and dune health.

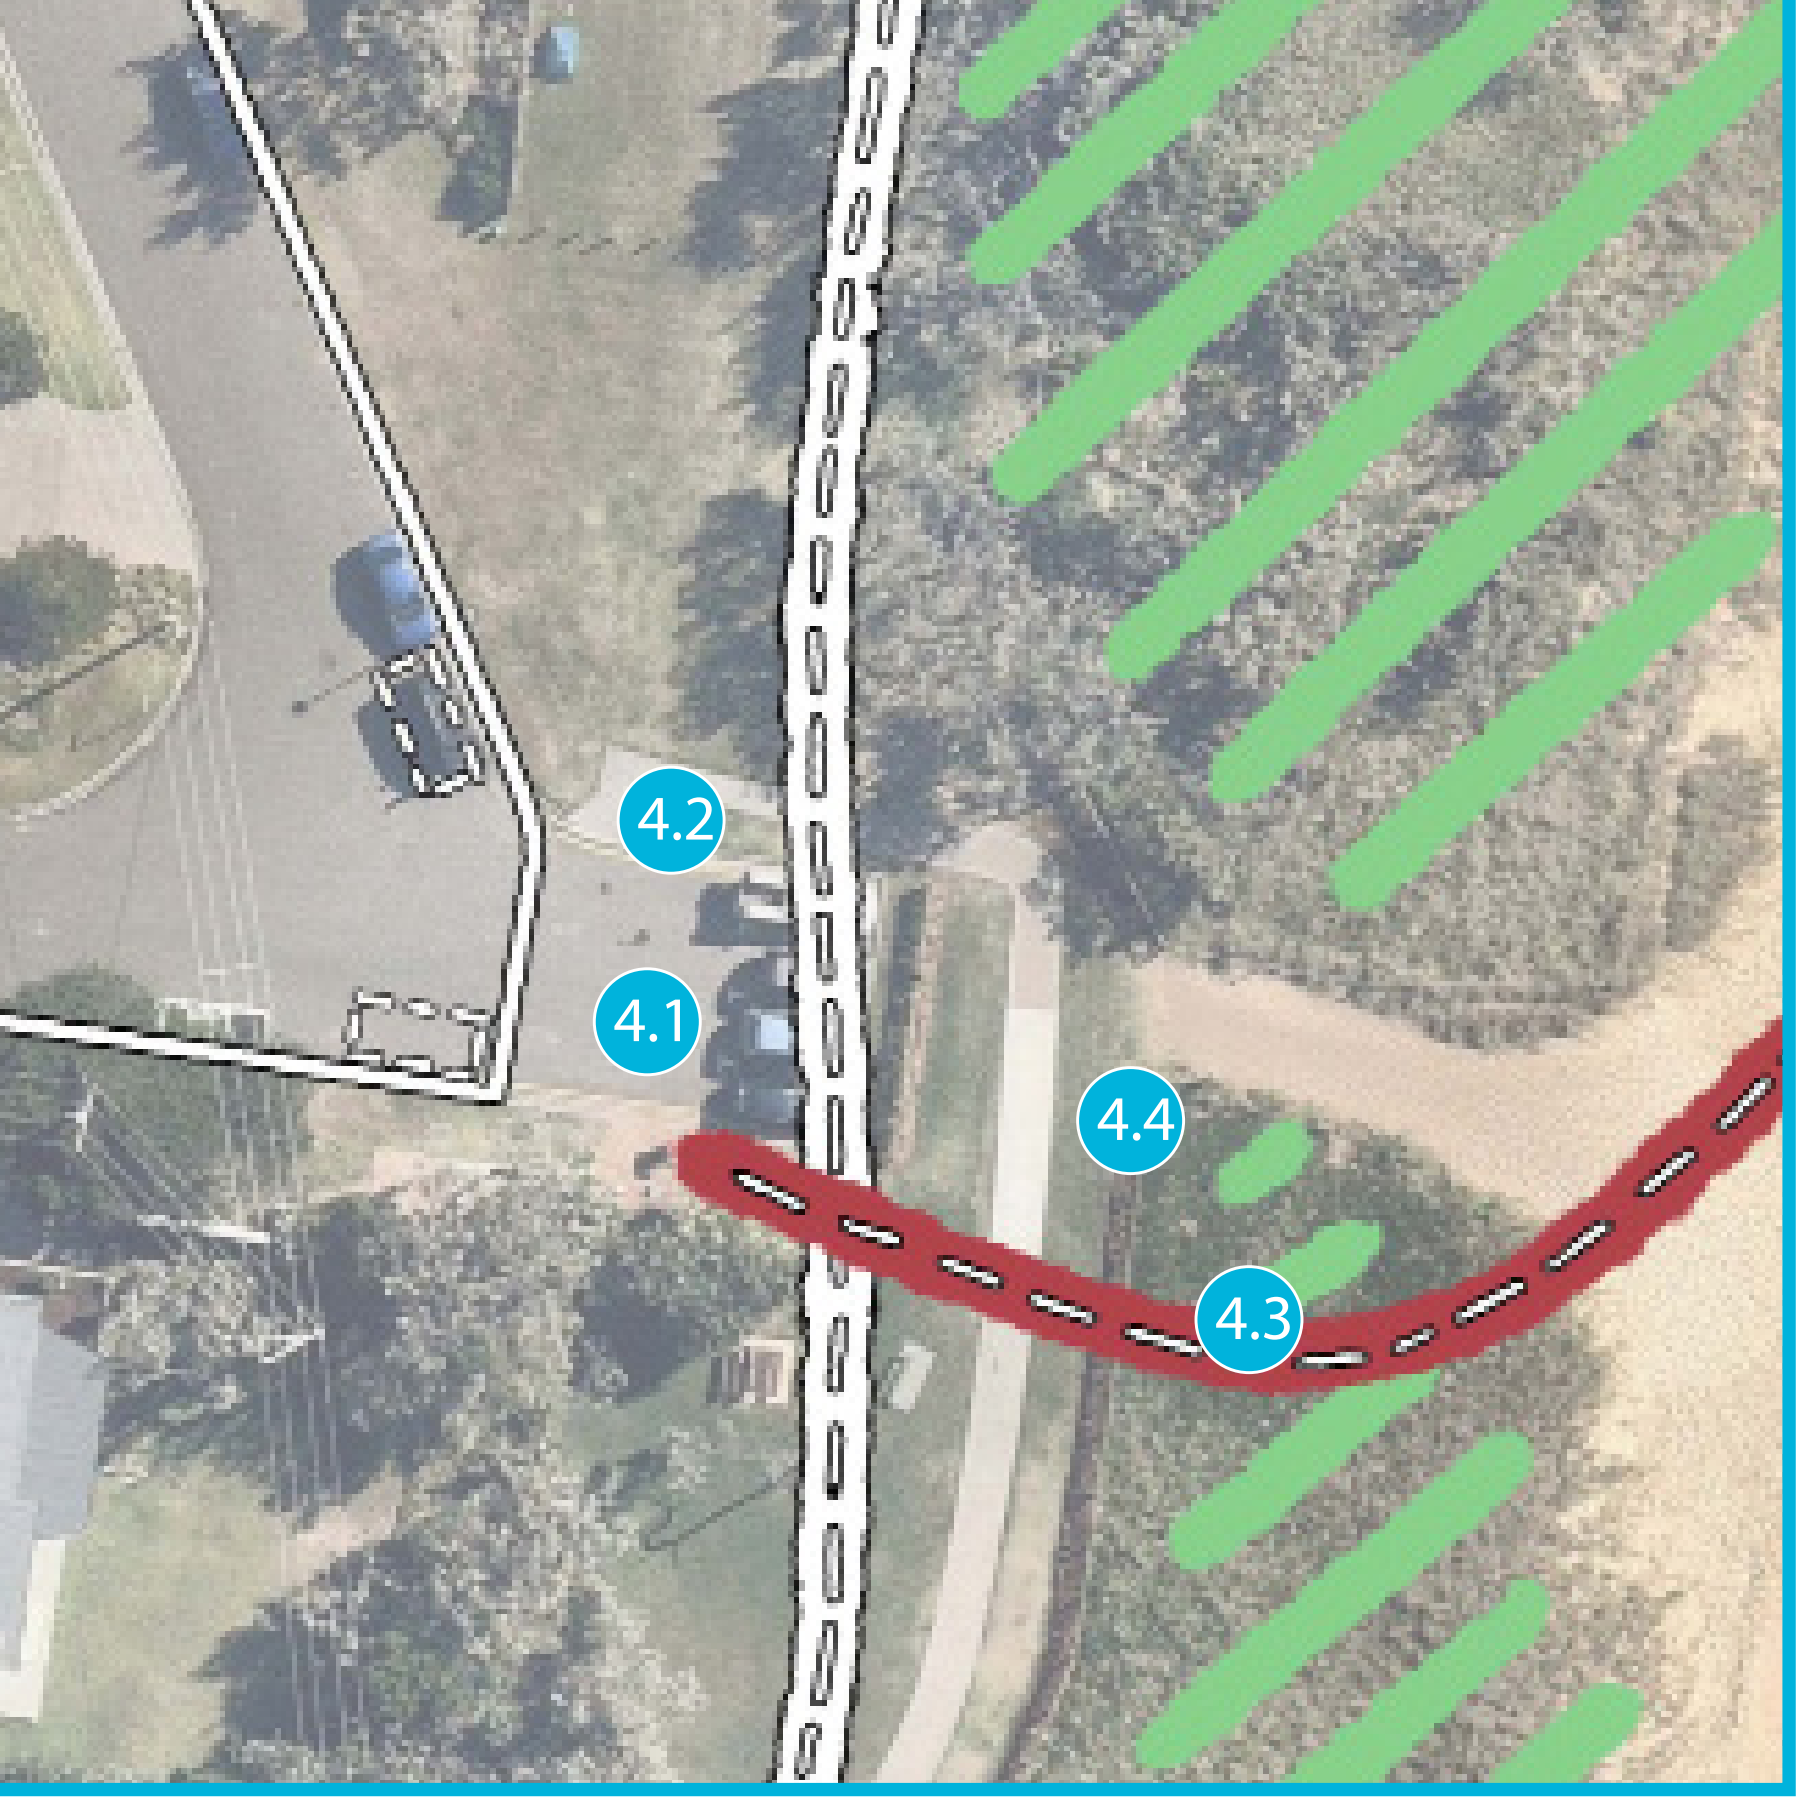
Option 4 - Remove car park

- 4.1 Remove current parking spaces (4no.) and replace with fewer on-street parking spaces.
- 4.2 Utilise space released from parking as part of the coastal corridor and park area.
- 4.3 Re-align beach access to face east and then north to provide shelter from the south-easterly breezes and contribute to reduction of light.
- 4.4 Introduce sensitively design viewing platform as part of the beach access and relocate memorial seat

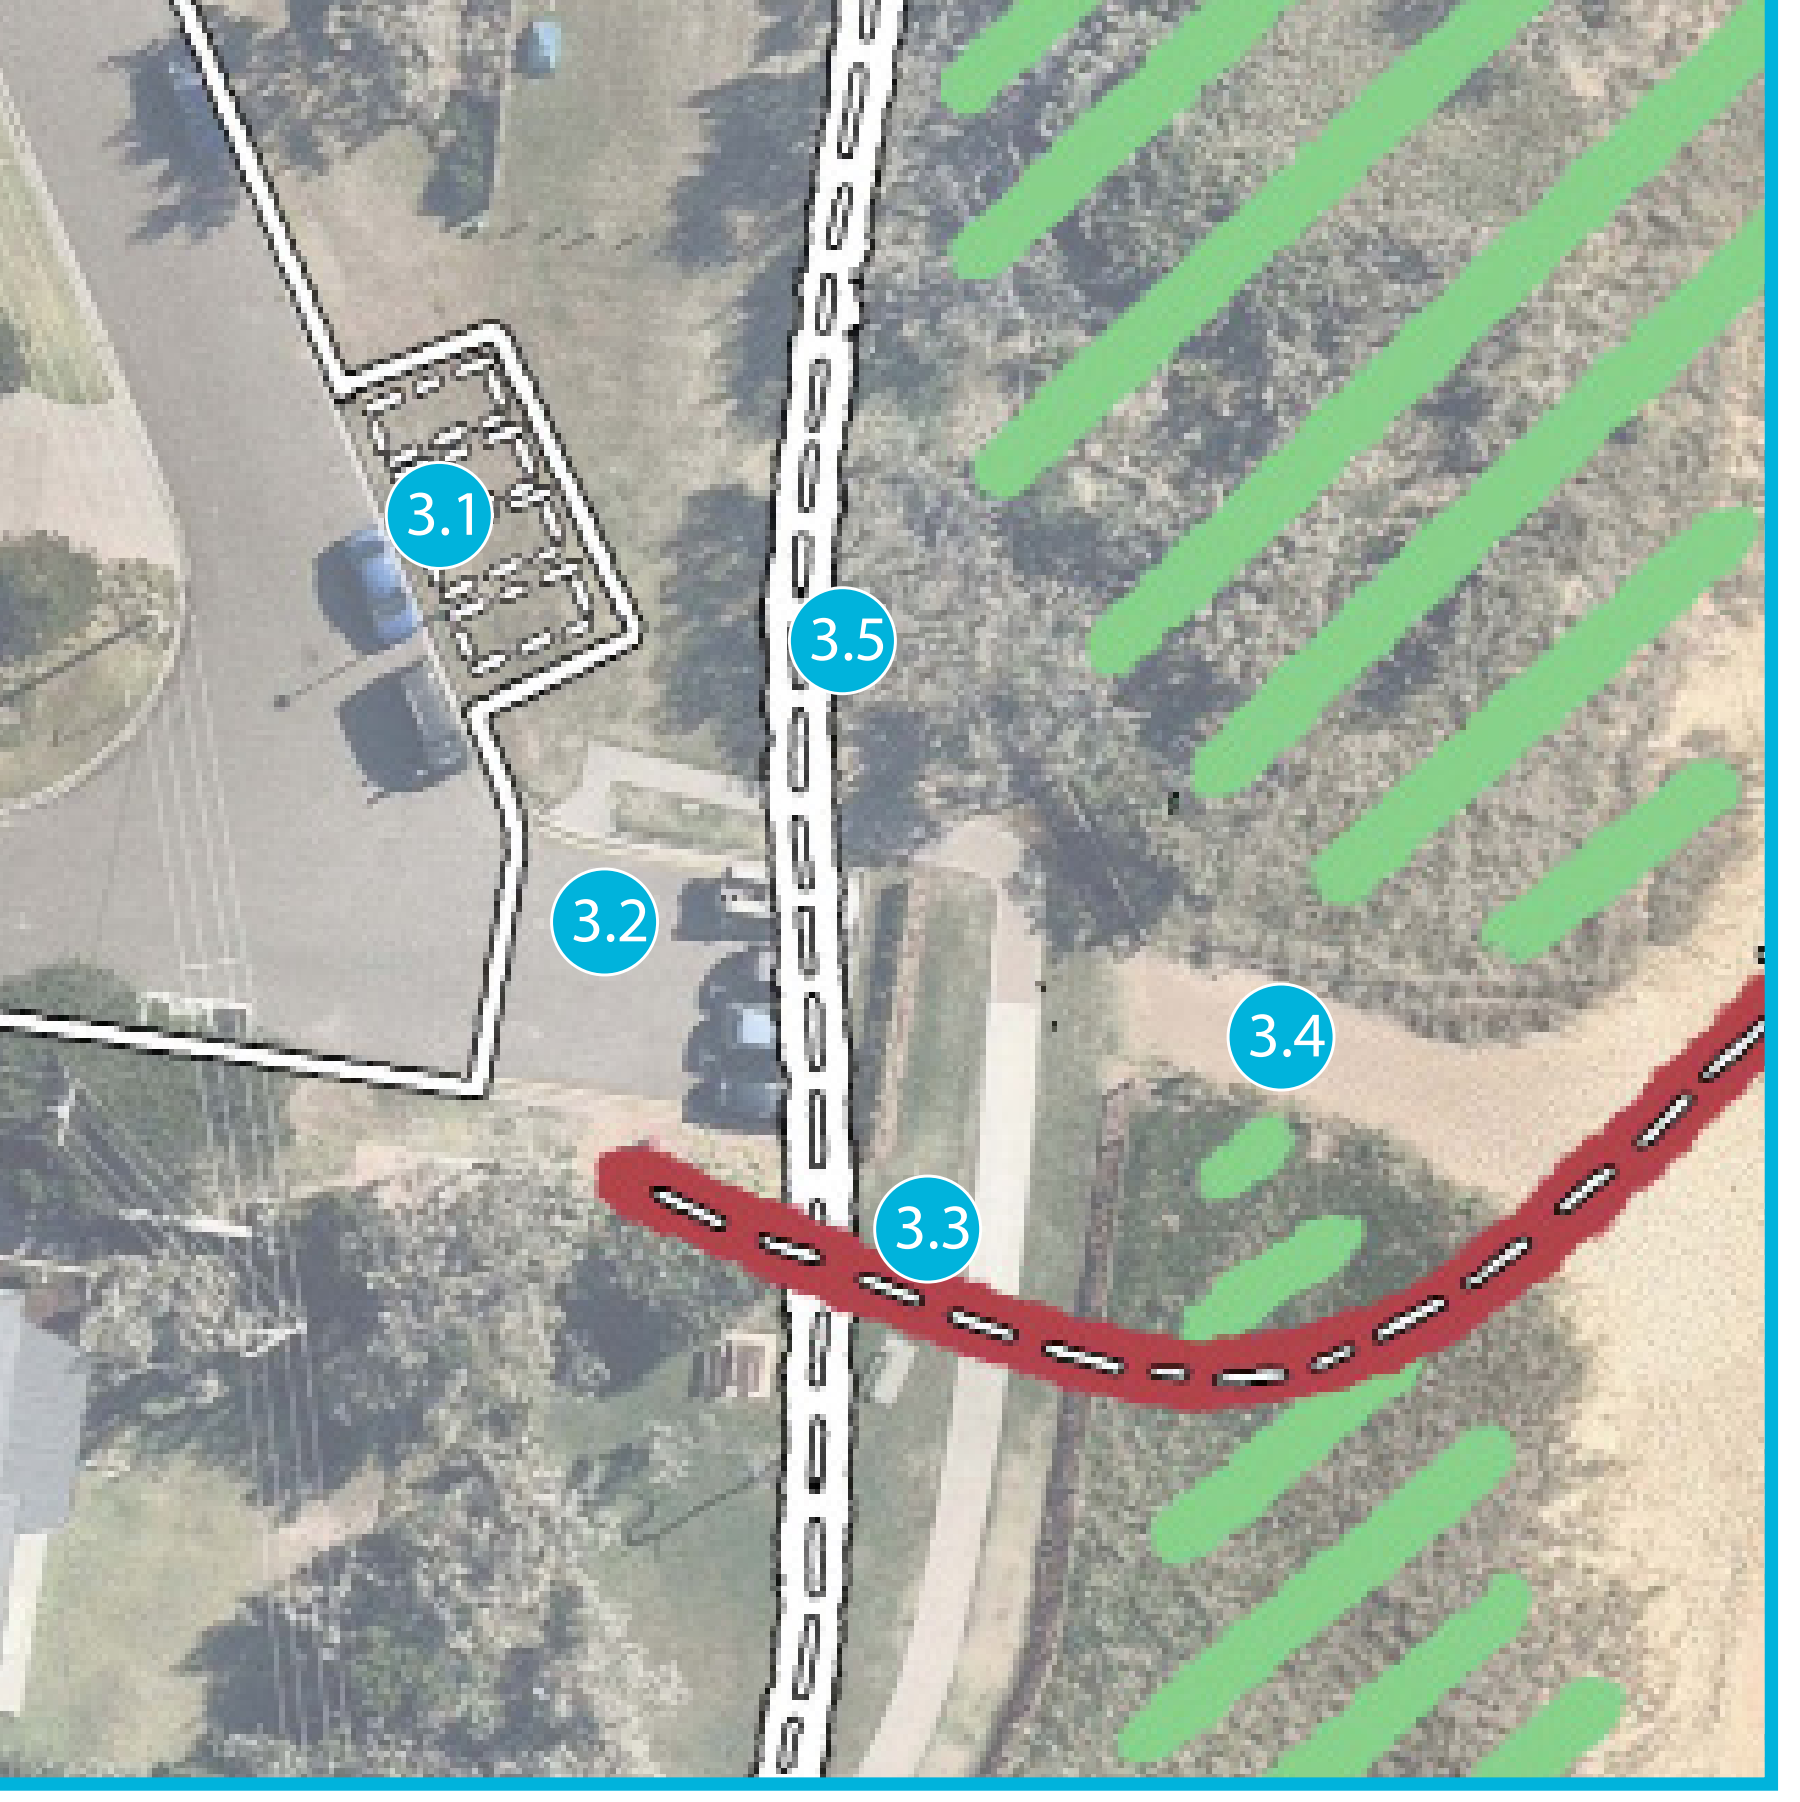
Option 3 - Relocate and realign parking

- 3.1 Relocate and realign parking bays away from beach entry to mitigate light spill.
- 3.2 Reclaim balance area of current car park as enhanced public open space.
- 3.3 Re-align beach access to provide shelter from the south-easterly breezes and contribute to reduction of direct light spill from adjacent road network.
- 3.4 Undertake appropriate dune planting to contribute to light spill reduction and dune health.
- 3.5 Straighten the section of coastal path in the vicinity of the William Street car park to eliminate the sharp bend, reduce conflict between users, and address safety and light spill concerns.
